# Status of Water Distribution Uniformity and Efficiency in several on Farm Drip Irrigation Networks

Some case studies in the Jordan Valley (Karamah)

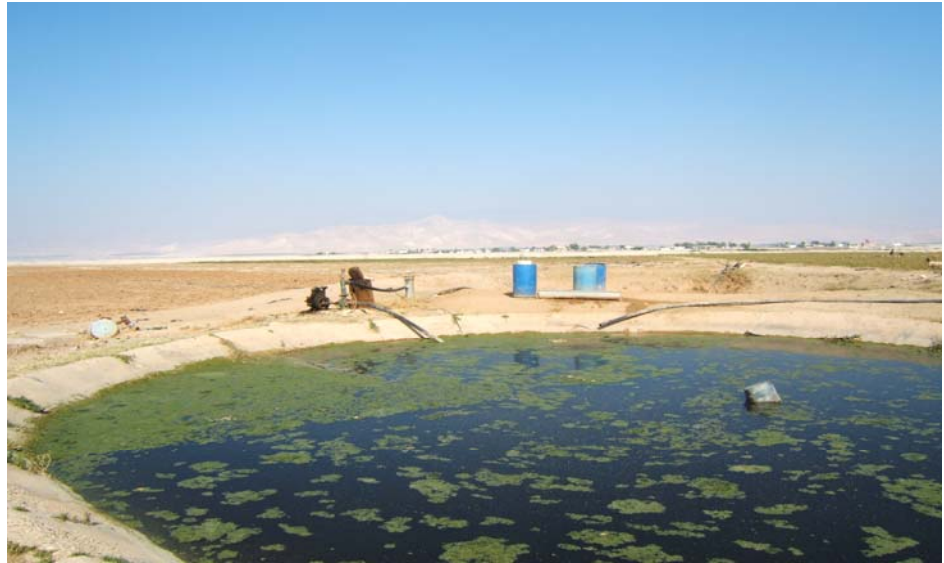
Common on farm pond, often invaded by algae. In this case, an old under-sized screen filter is placed between the diesel pump and the irrigation net.

Due to the very bad quality of water (both organic and physical spoiling/polluting agents are present), it is mandatory to adopt the sand filtration. Followed by disks filter as ultimate precaution

Thus the existing traditional "sand filters" are useless, because their horizontal design, the absence of proper bottom diffusers and because the used media (gravel instead of silica or quartzite sand 0,8-1,2 mm).

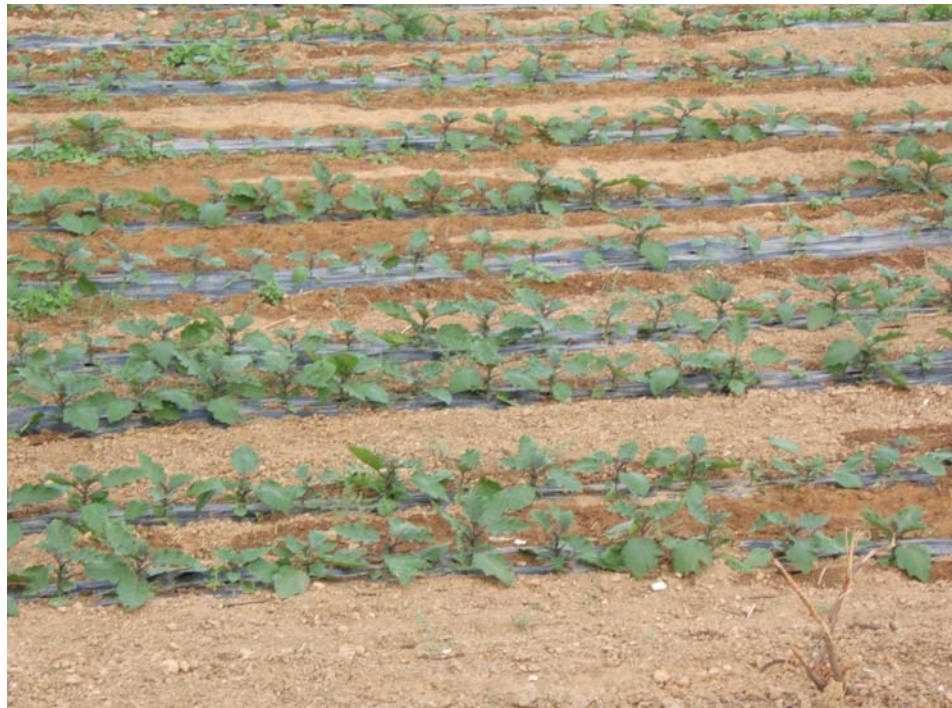
Lack of watering uniformity: the second row appears under irrigated, whilst the adjacent rows show large over watering.

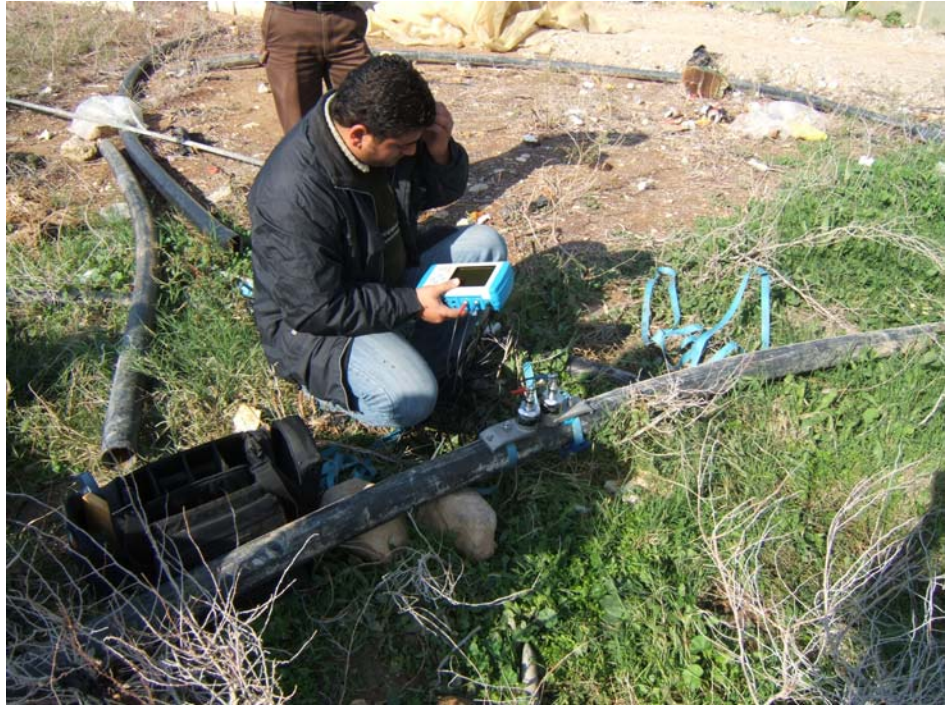
Checking the flow on the mainline by the portable ultrasonic clamp flowmeter

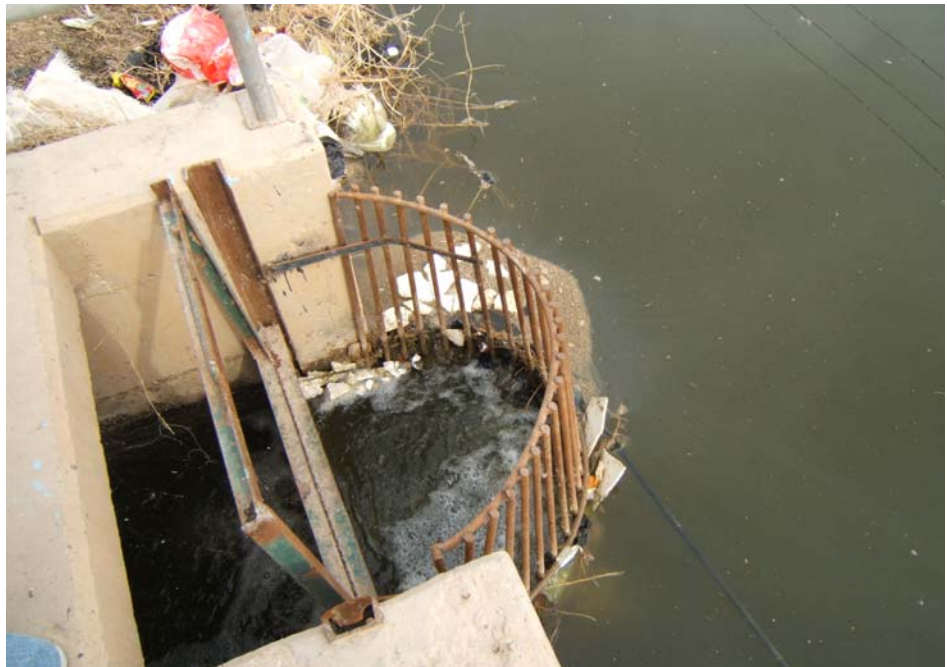
The standard inlet at the TO on the KAC: the quality of water is quite bad and the preliminary filtration clearly unsatisfying.
