Improvement of Irrigation Water Management in Lebanon & Jordan

FINAL REPORT

Rehabilitation of the River Litani and the affluents

Bekaa Valley

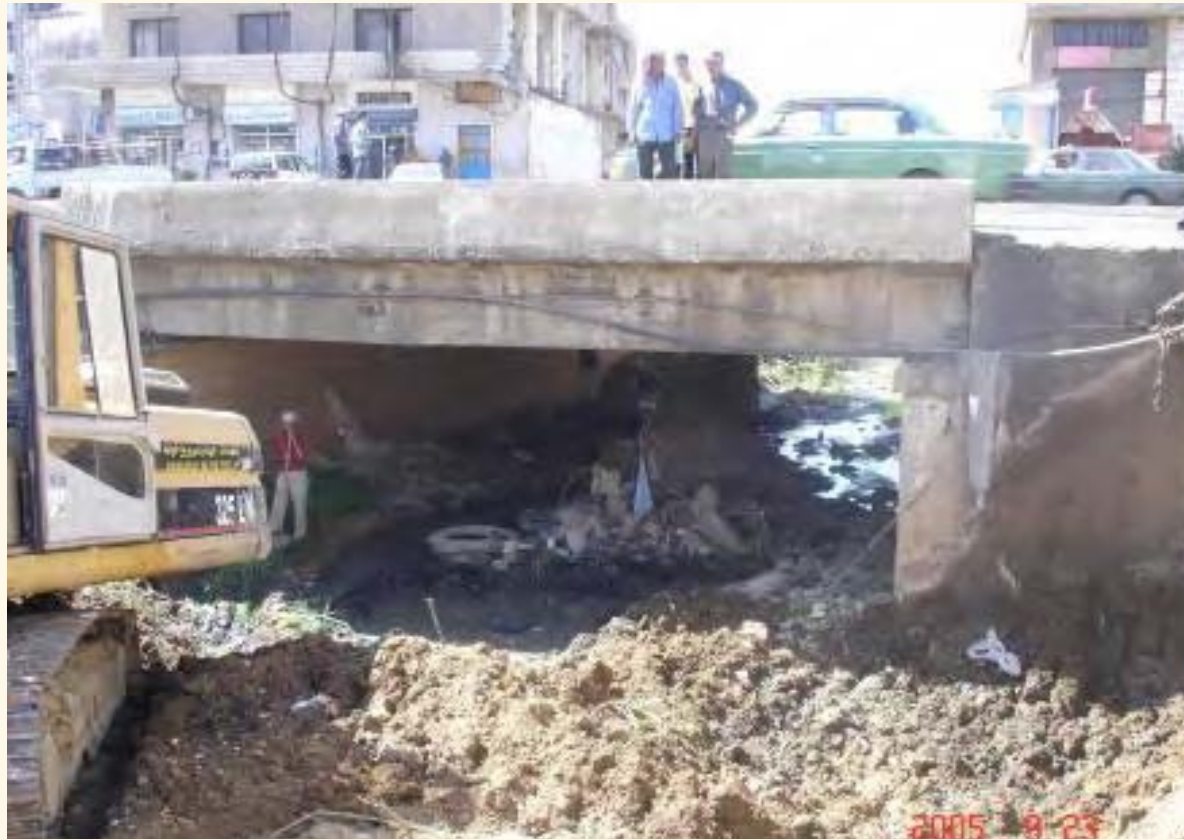
BEFORE THE WORKS

The situation of the Litani River in L1 point before the jobs were characterized by a complex condition. The river was encircled from the buildings. This point is very important because is located on the Damascus road and near to the houses. The bed of the river in proximity of the bridge was tall due to the solid deposition and the uncontrolled discharge of garbage, this limits the flow that could pass trough the bridge. The bridge is also characterized by the presence of pipages hung to the deck.

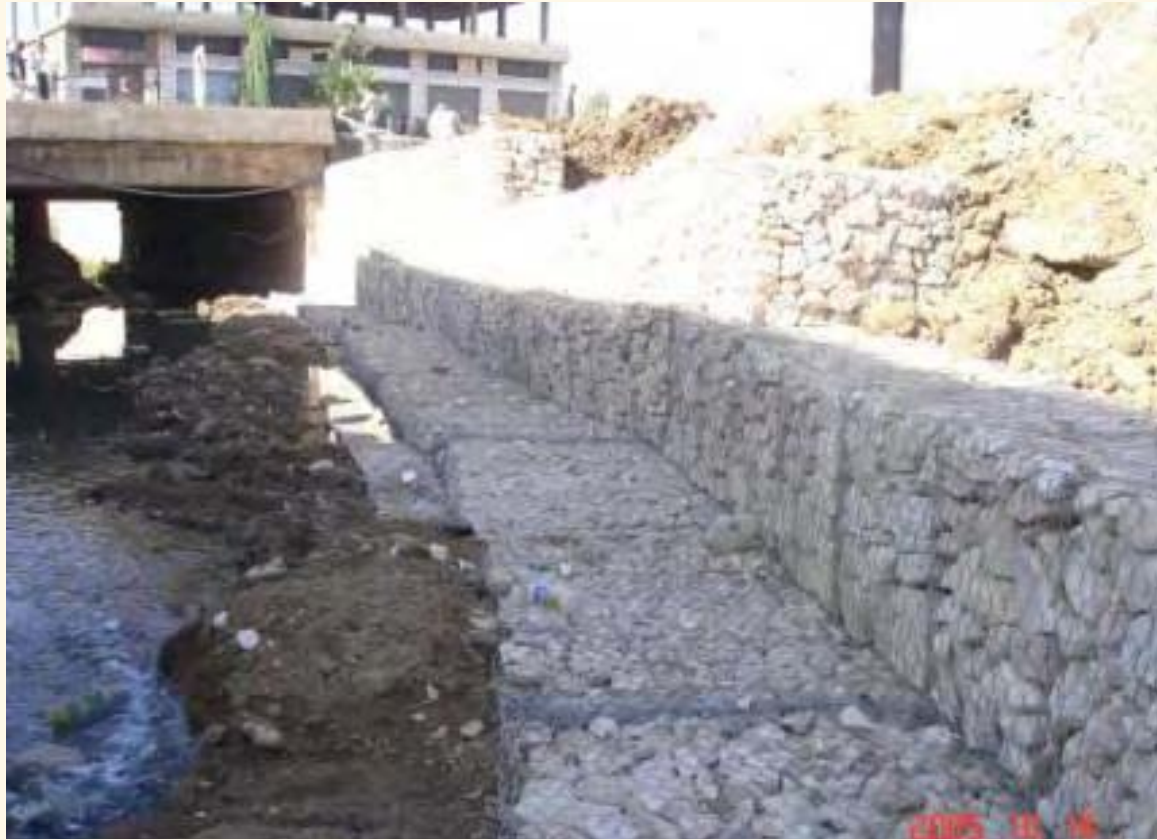
AFTER THE WORKS

The works completed according to the project previsions have concurred to reach better conditions for the river flows.
 The recalibration of the river bed and banks have granted safer condition for the bridge increasing the potential maximum river flow.
 The new protections (gabions and geocomposite)of the river banks are more sustainable and permit a simple maintenance.
 The houses and the Damascus road are safer from the floods.

During the works, according to the preliminary hydraulic evaluation we recalibrate the river section cleaning the section of the river under the bridge.
We model new river banks with appropriate inclination (1:3) compatibly with the new protections.
We Execute gabions mattresses and geocomposite.

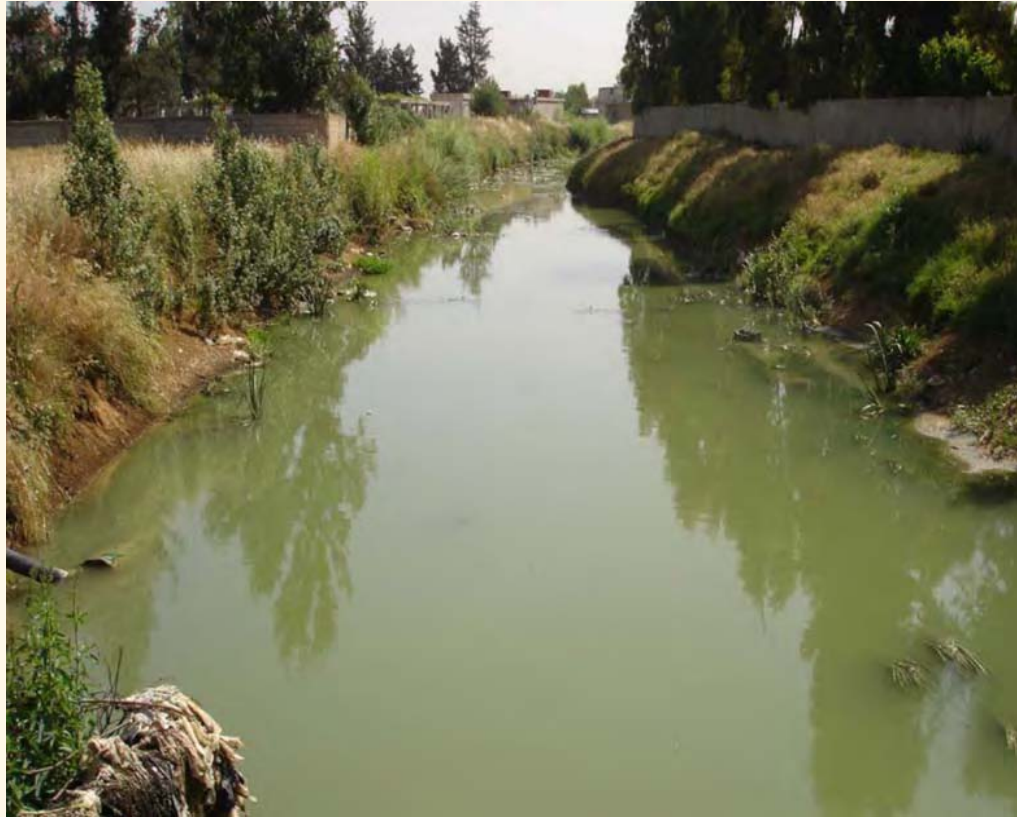
BEFORE THE WORKS

The situation of the Litani River in L3 point before the jobs were characterized by a complex condition. The area was characterized by several episode of flood with damages for the private properties, agricultural area and problems for the road circulation. This causes danger because the connection with other villages was so difficult. The bed of the river in proximity of the bridge was tall due to the solid deposition, and also the bridge was characterized by the presence of pipages hung to the deck. This limits the flow that could pass trough the bridge and causes the floods.

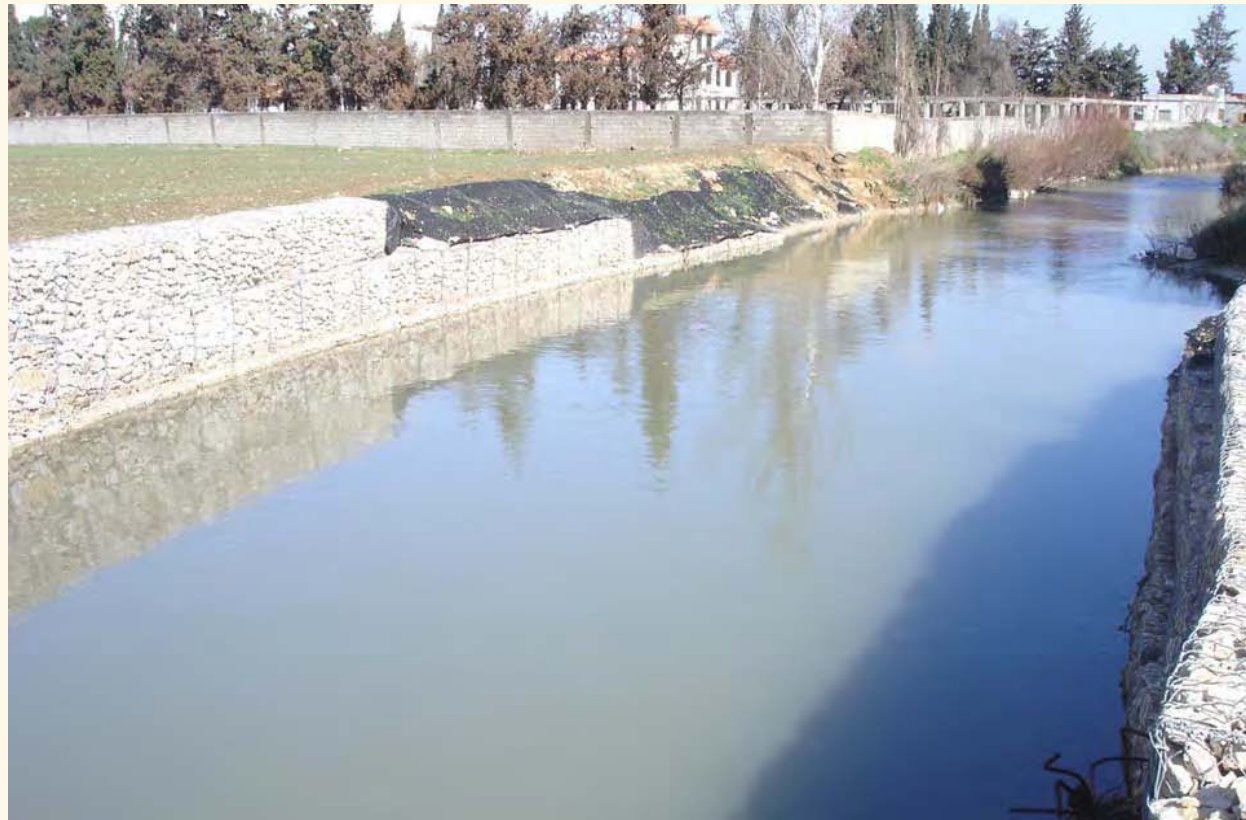
AFTER THE WORKS

The works completed according to the project previsions have concurred to reach better conditions for the river flows.
 The recalibration of the river bed and banks have granted safer condition for the bridge.
 The new protections (gabions and geocomposite) of the river banks are more sustainable and permit a simple maintenance.
 Cultivated lands are safer from the flooding and

During the works, according to the preliminary hydraulic evaluation we enlarge the width of the river to 18 m.
We model new river banks with appropriate inclination (1:3) compatibly with the new protections
We Execute 160 m. of gabions & geocomposite for every side of the river, cleaning the bed and recalibrating the banks for approximately 4 Km.
We extend the pipes and create a correct intersection with the river

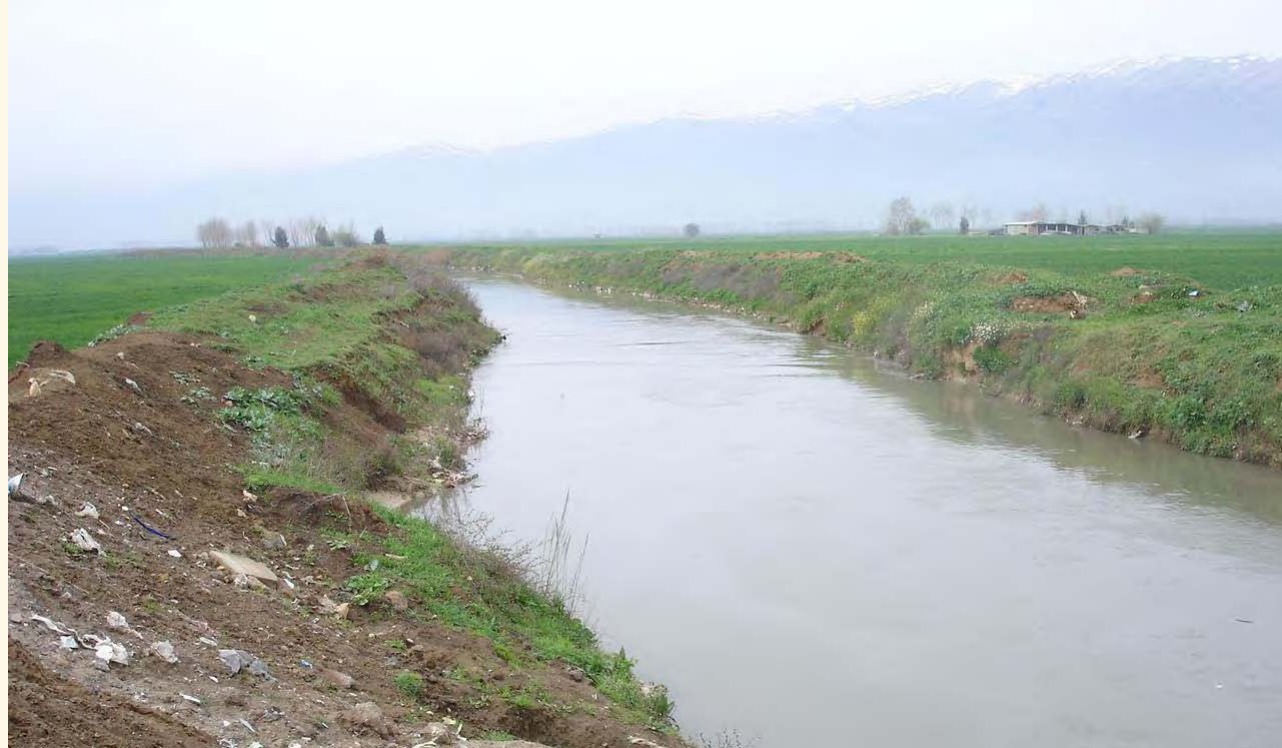
AFTER THE WORKS

After the works we have guaranteed a better flow condition to prevent flood and protect the local activities (cow farm)

During the works, according to the preliminary hydraulic evaluation we have recalibrate the river section for a length of about 4 km

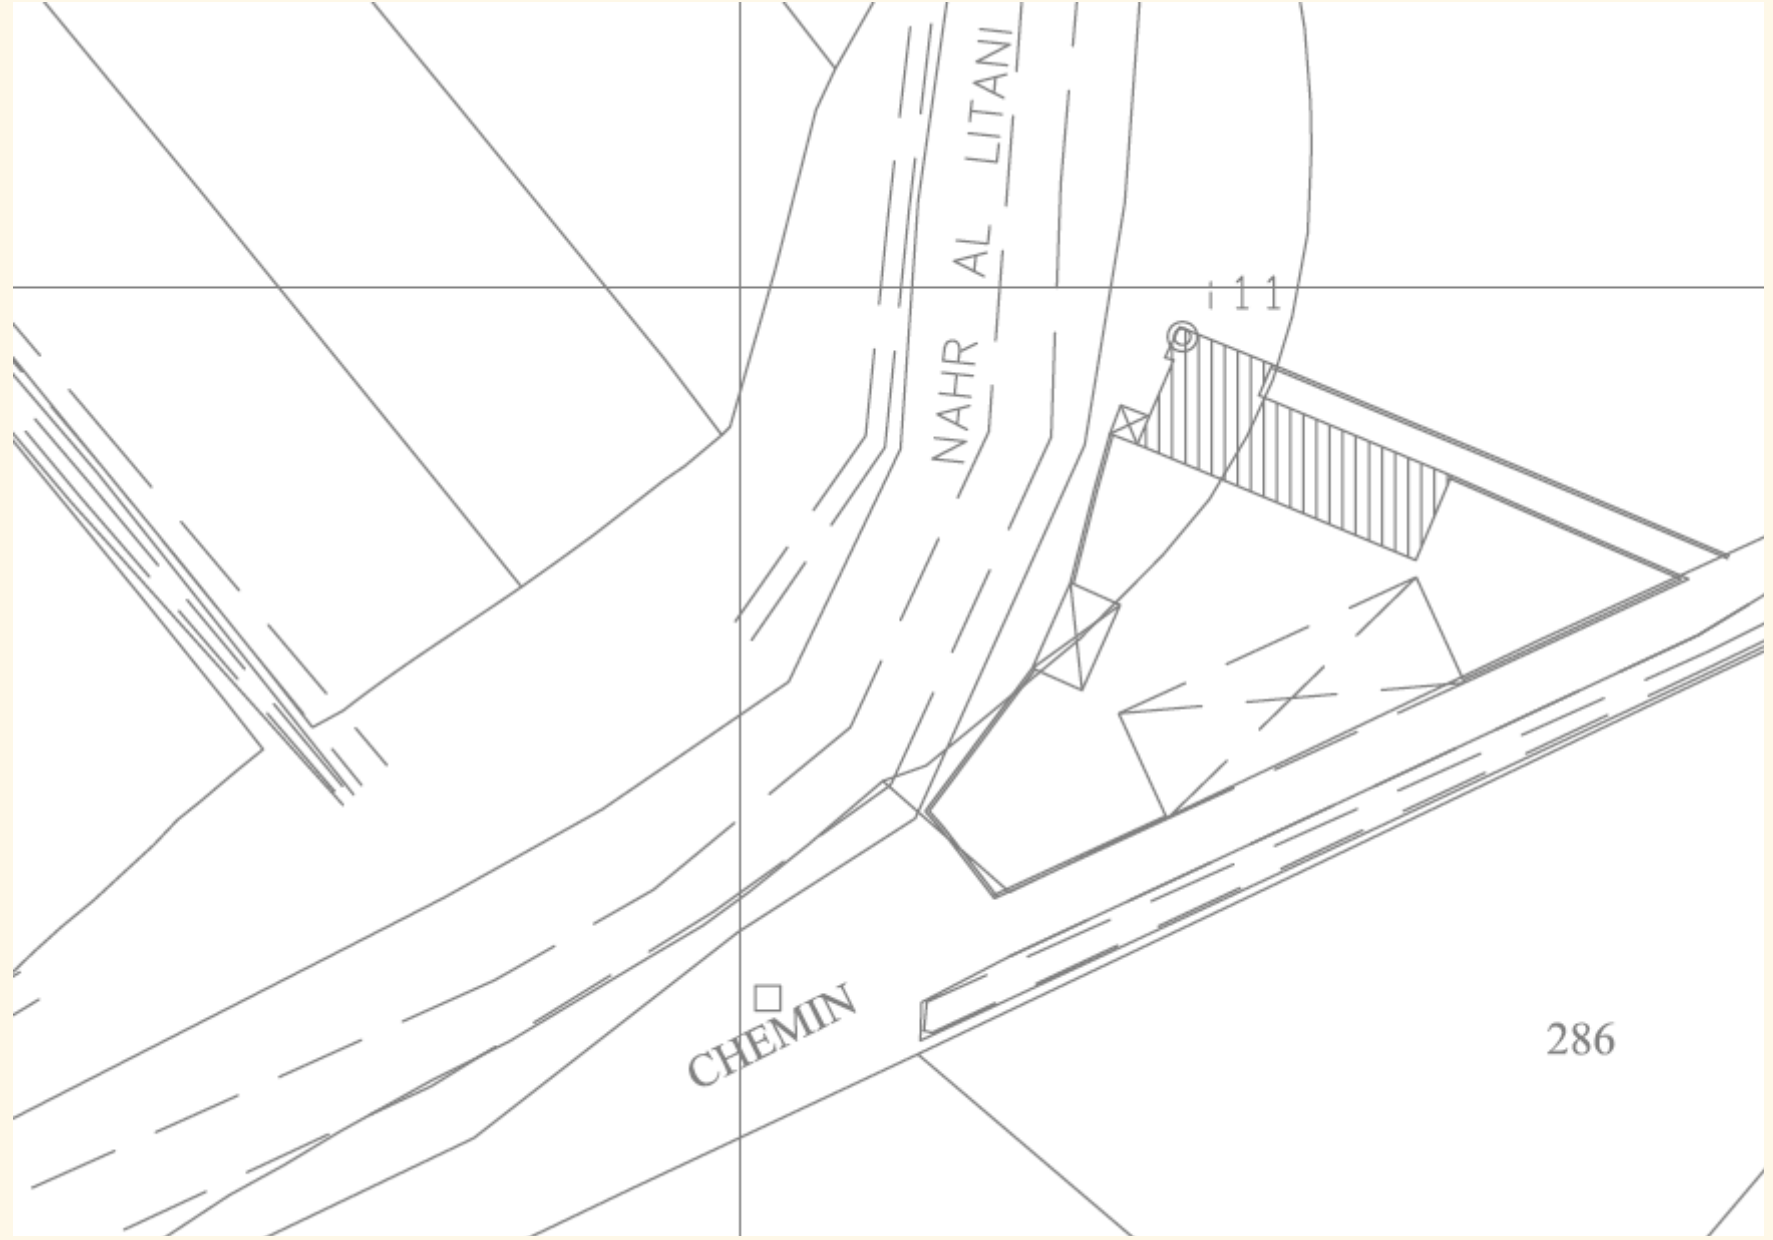
AS – BUILT CONDITIONS

Reference Data: Litani River, L4 POINT

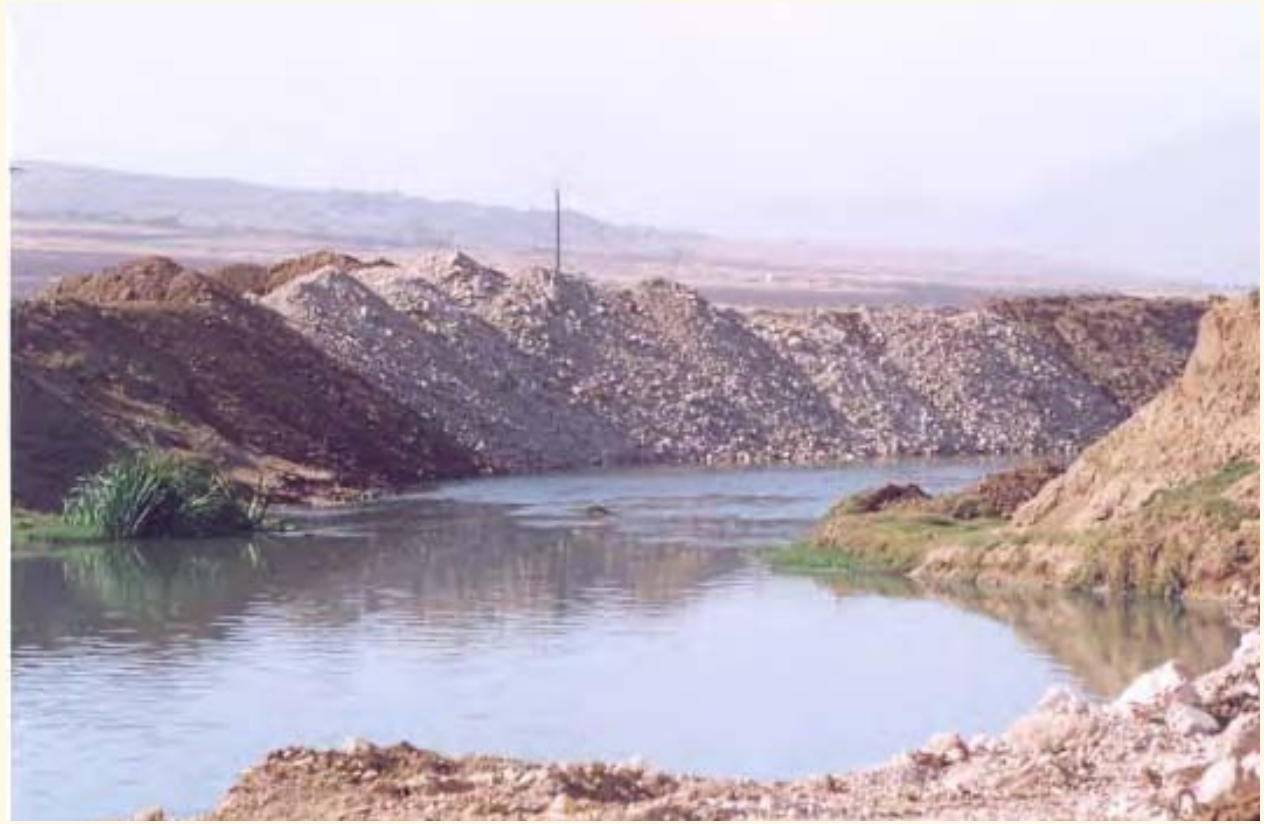
DURING THE WORKS

Backfilling the area with rocks as foundation and covered with selected soil. (Volume 6330 m3) - Re-calibration of the banks for 200 Lm.

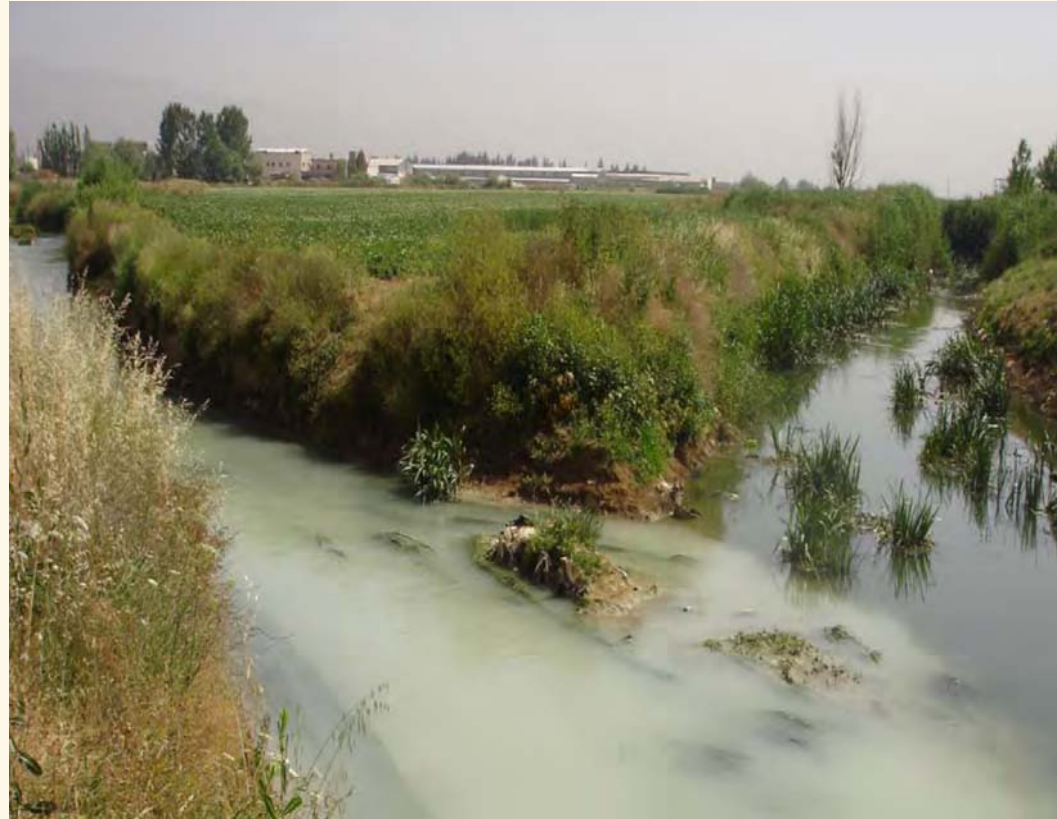
BEFORE THE WORKS

The situations at the confluence of the Litani River and Berdaouni River before the jobs were characterized by river banks without protection and with heavy signs of erosion. Some dams are located in the river obstructing the flow.
 The width of the section was variable and locally was too much low to permit the regular flow of the water in case of peak flows. This situation causes several case of flooding with bad conditions for the agriculture.

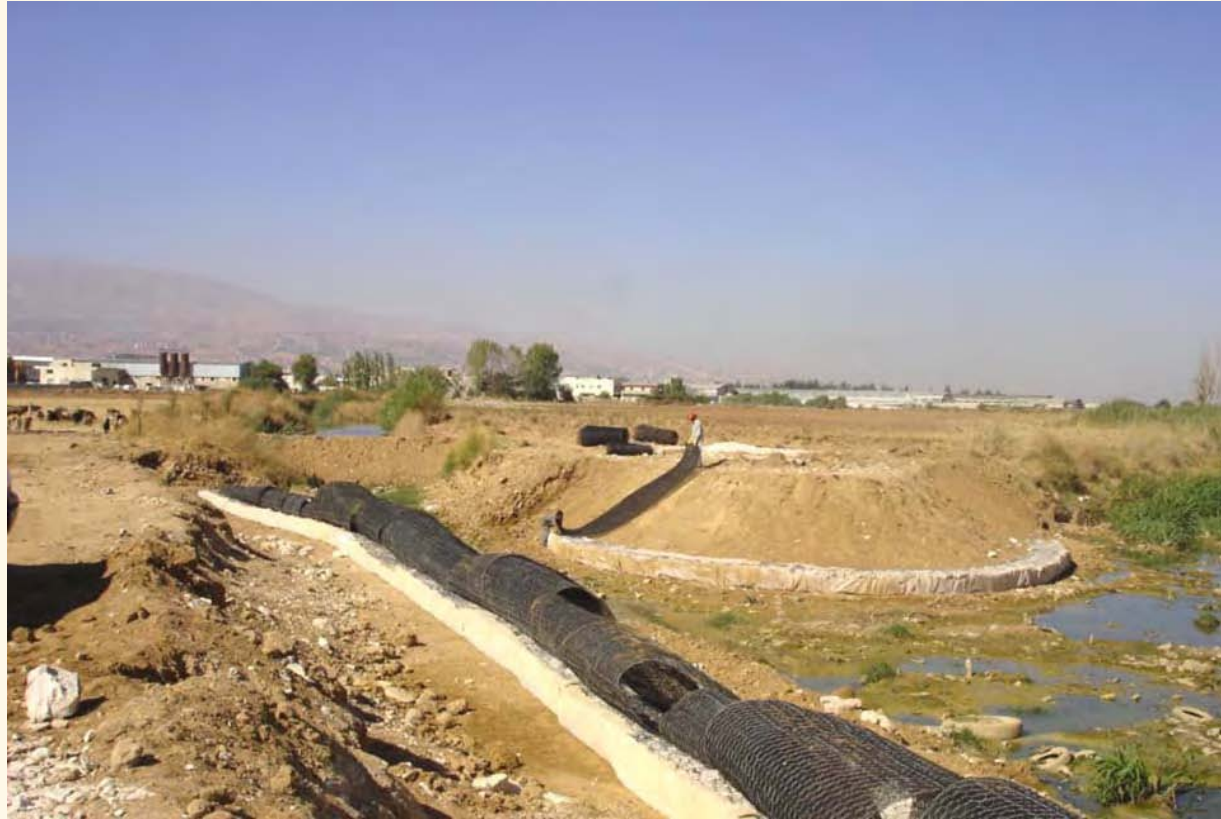
During the works, according to the preliminary hydraulic evaluation we enlarge the width of the river to reach a safer condition of flow. We model new river banks with 3 Km of recalibration. We execute mattresses and gabions with geocomposite on every bank.

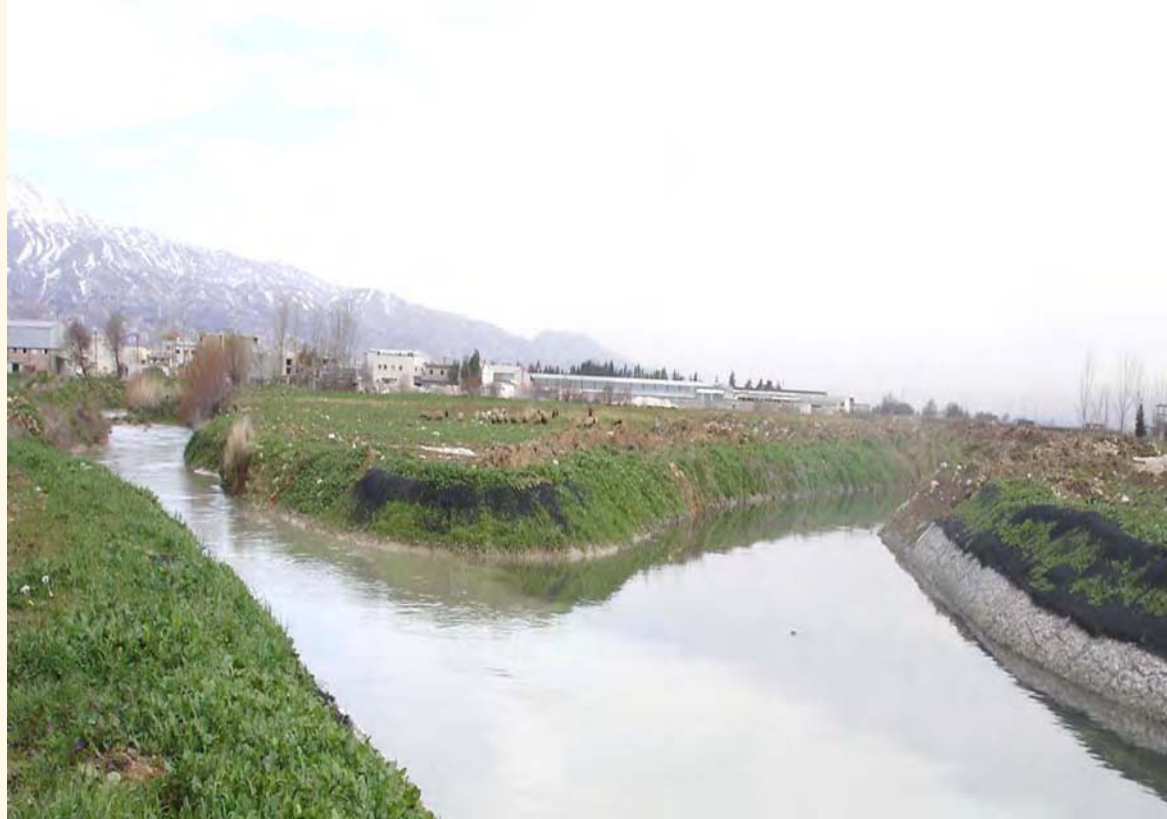
AFTER THE WORKS

The works completed according to the project previsions have concurred to reach better conditions for the river flows.
 The recalibration of the river bed and banks have granted safer condition in case of flood.
 The new protections (gabions and geocomposite) of the river banks are more sustainable and permit a simple maintenance.
 Cultivated lands are safer from the flooding.

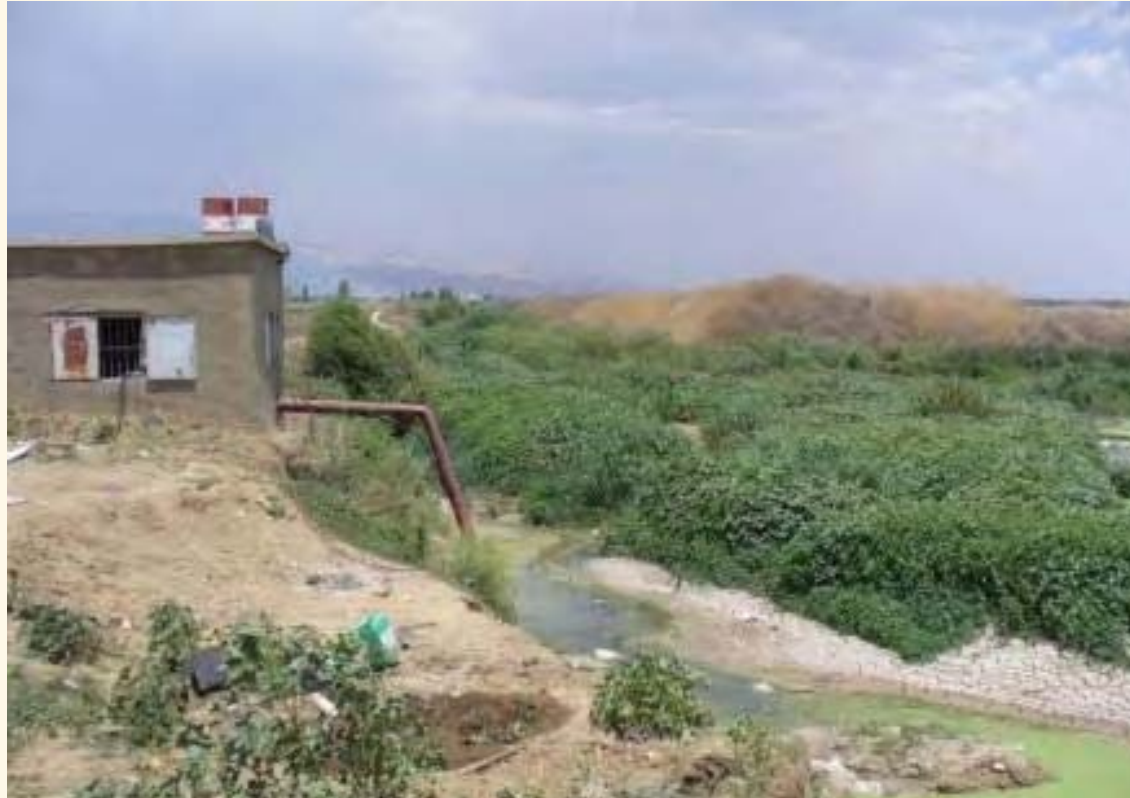
The situations at the confluence of the Litani River and Ghzaiyel River before the jobs were characterized by some dams located in the river obstructing the flow.
The width of the section was variable and locally was too much low to permit the regular flow of the water in case of peak flows. There are the presence of a pump station in proximity of the river banks with problem of stability in case of evolution of the erosion.
This general situation causes several case of flooding with bad conditions for the agriculture.

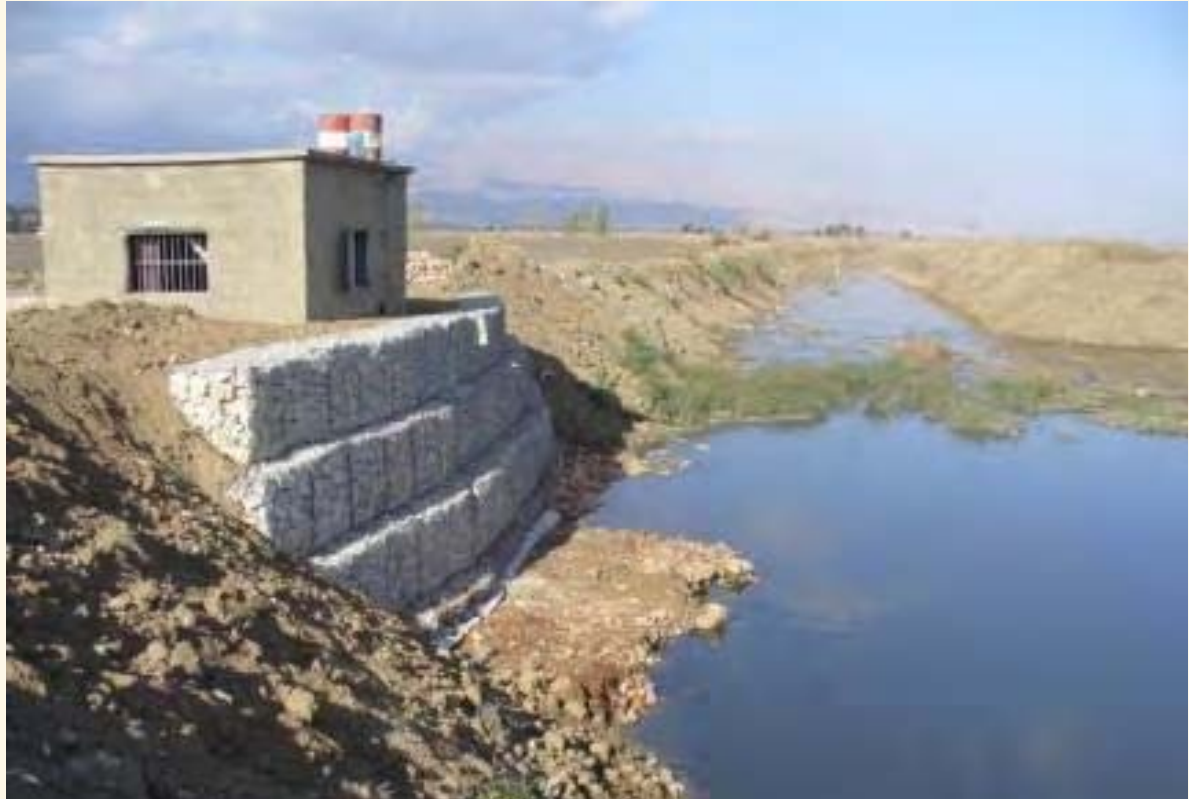
AFTER THE WORKS

The works have concurred to reach better conditions for the river flows. The recalibration of the river bed and banks have granted safer condition in case of flood. The new protections of the river banks near the pump station prevent the erosion and protect the building from flood.

| Explanation | <p>The works executed on 2007 comprise:</p> <ul style="list-style-type: none"> - Gabions for 20 Lm - Total river re-calibration along Litani and Ghzaiyel river too for a total of 4.3 Km upstream and downstream of the confluence. Executed by the L.R.A. and partially with funds of the project | |

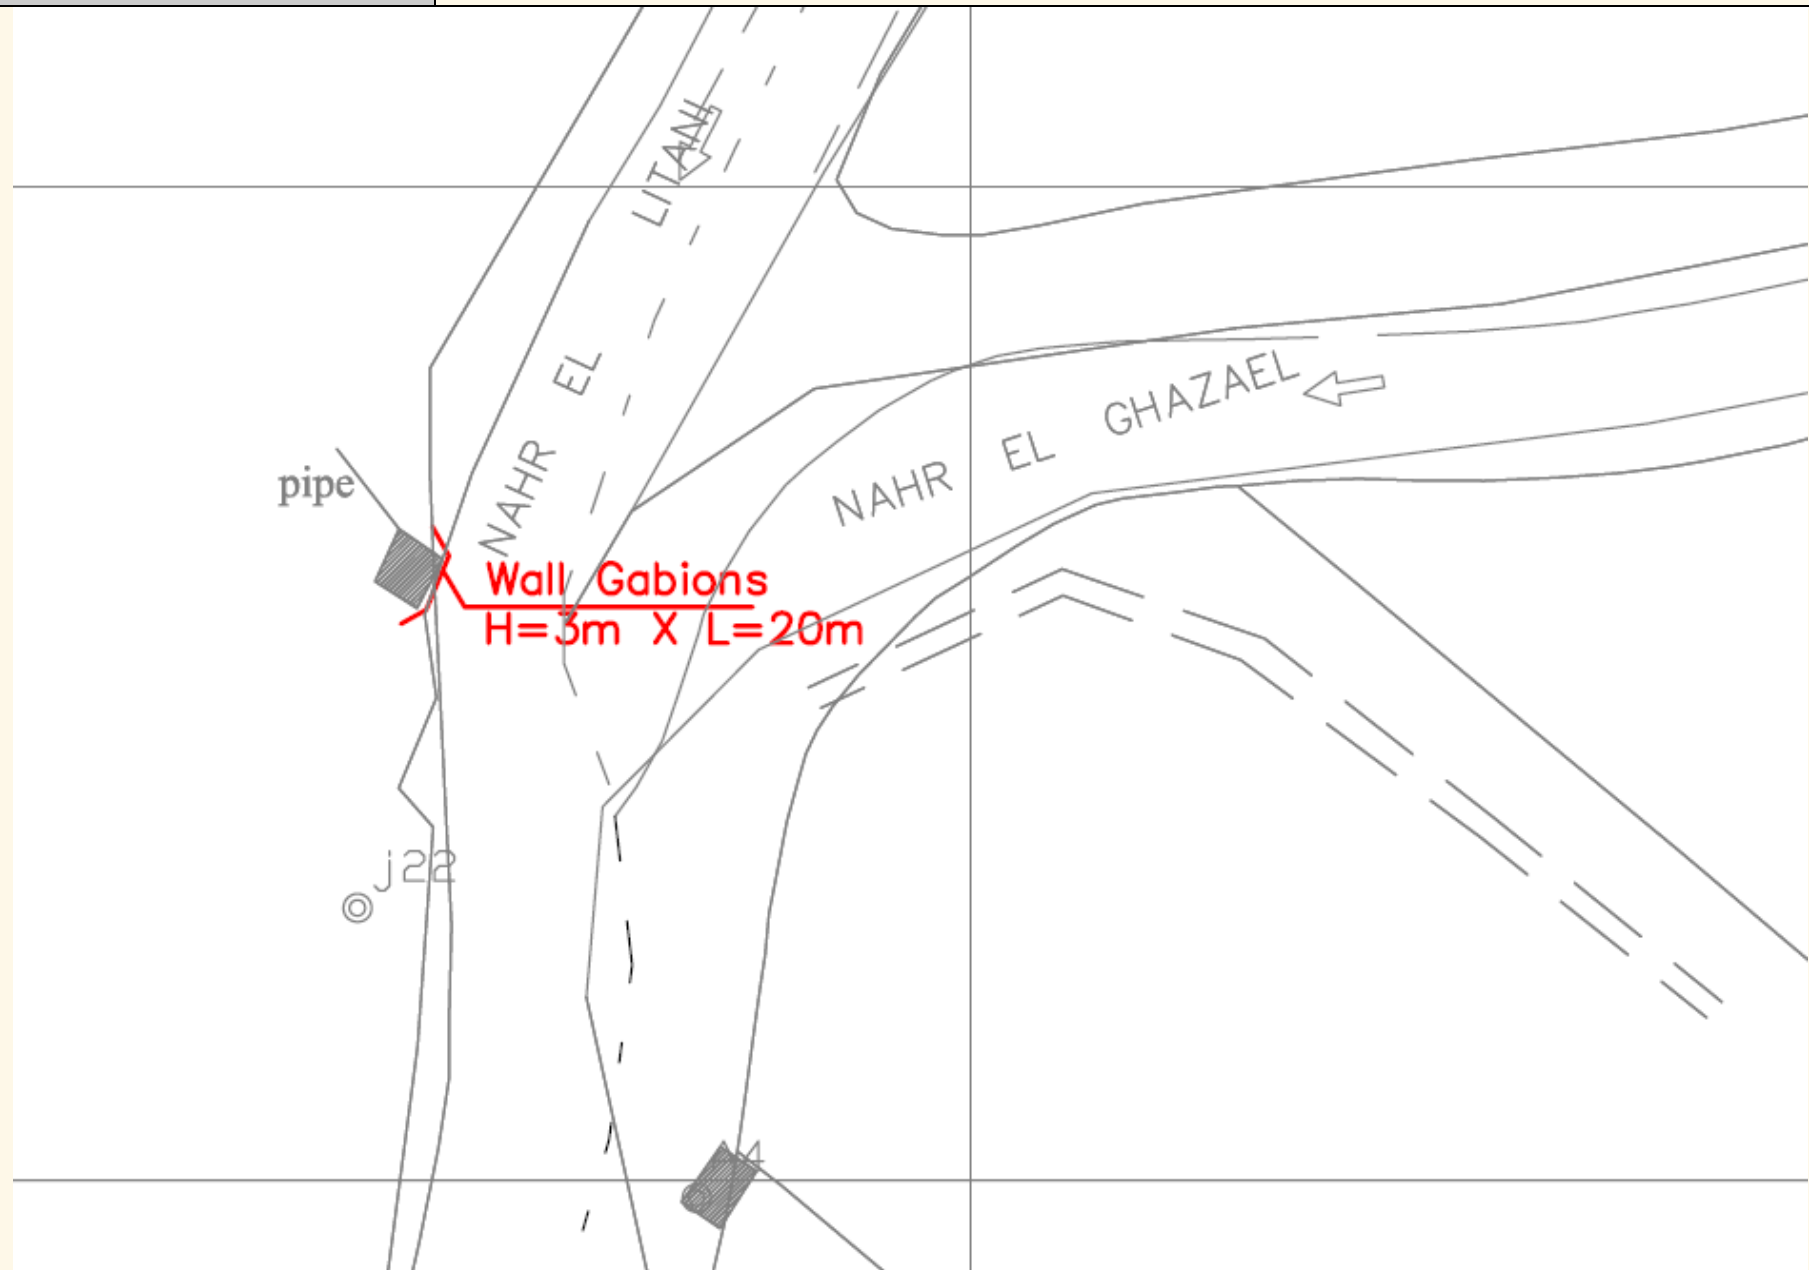
AS - BUILT CONDITIONS

Litani River, Ghzaiel River, LG8 POINT

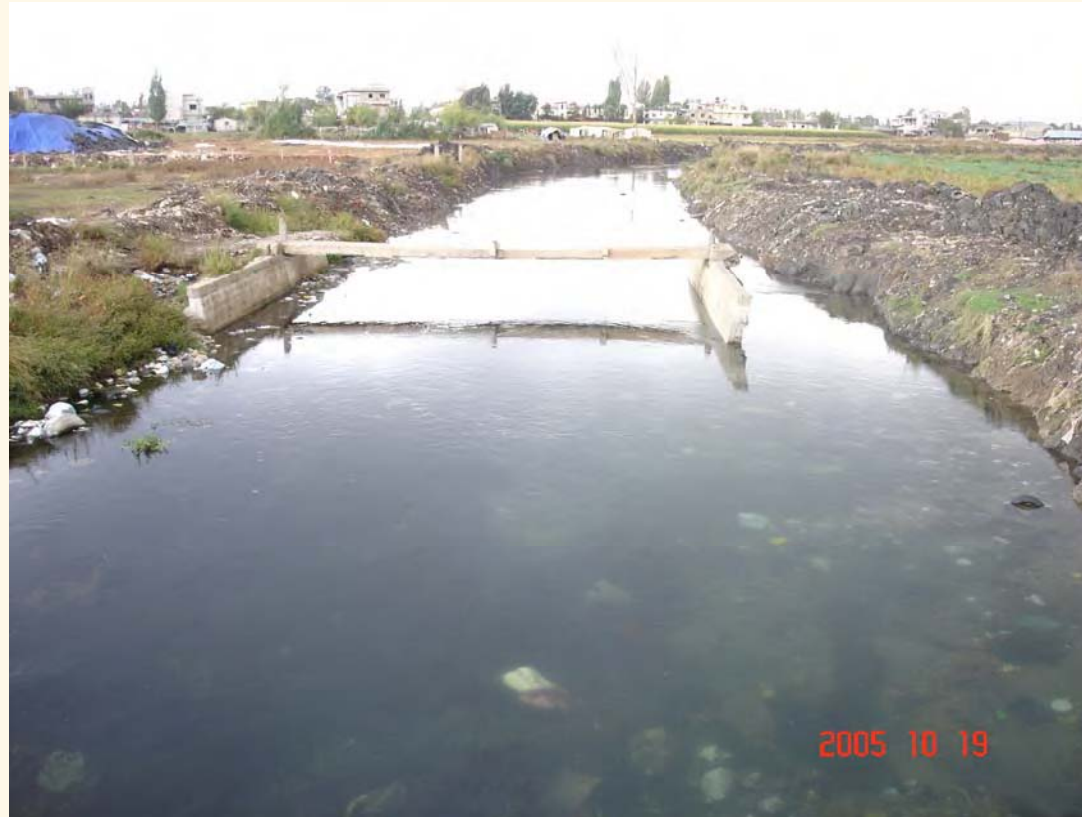
The situations of the Gzayel River before the jobs were characterized by river banks without protection and with heavy signs of erosion. The bed of the river in proximity of the bridge was tall due to the solid deposition and the uncontrolled discharge of garbage, This limits the flow that could pass through the bridge. The width of the section was variable and locally was too much low to permit the regular flow of the water in case of peak flows. This situation causes several case of flooding with bad conditions for the agriculture. Near the bridge we can found waste water pipe that without control discharge sewage into the river.

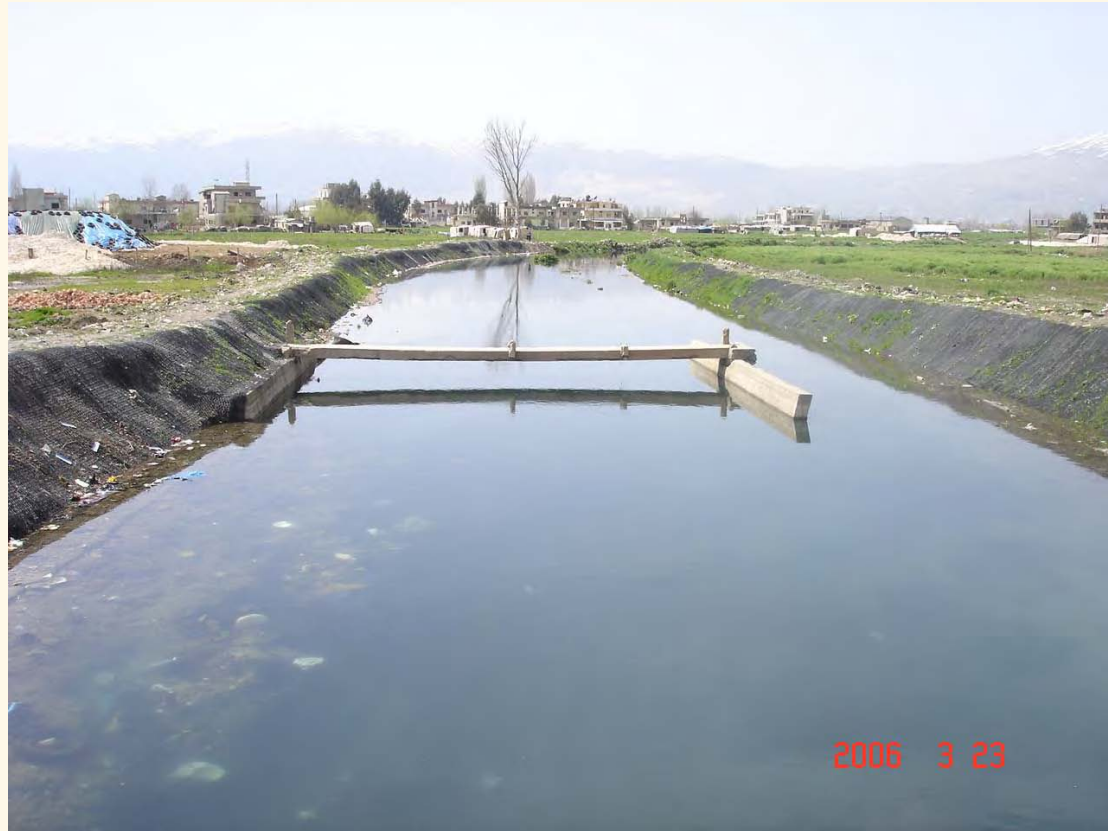
The works completed according to the project previsions have concurred to reach better conditions for the river flows.
 The recalibration of the river bed and banks have granted safer condition for the bridge.
 The new protections (gabions and geocomposite) of the river banks are more sustainable and permit a simple maintenance.
 Cultivated lands are safer from the flooding.

During the works, according to the preliminary hydraulic evaluation we enlarge the width of the river to 18 m.
We model new river banks with appropriate inclination (1:3) compatibly with the new protections
We Execute 160 m. of gabions & geocomposite for every side of the river, cleaning the bed and recalibrating the banks for approximately 4 Km.
We extend the pipes and create a correct intersection with the river

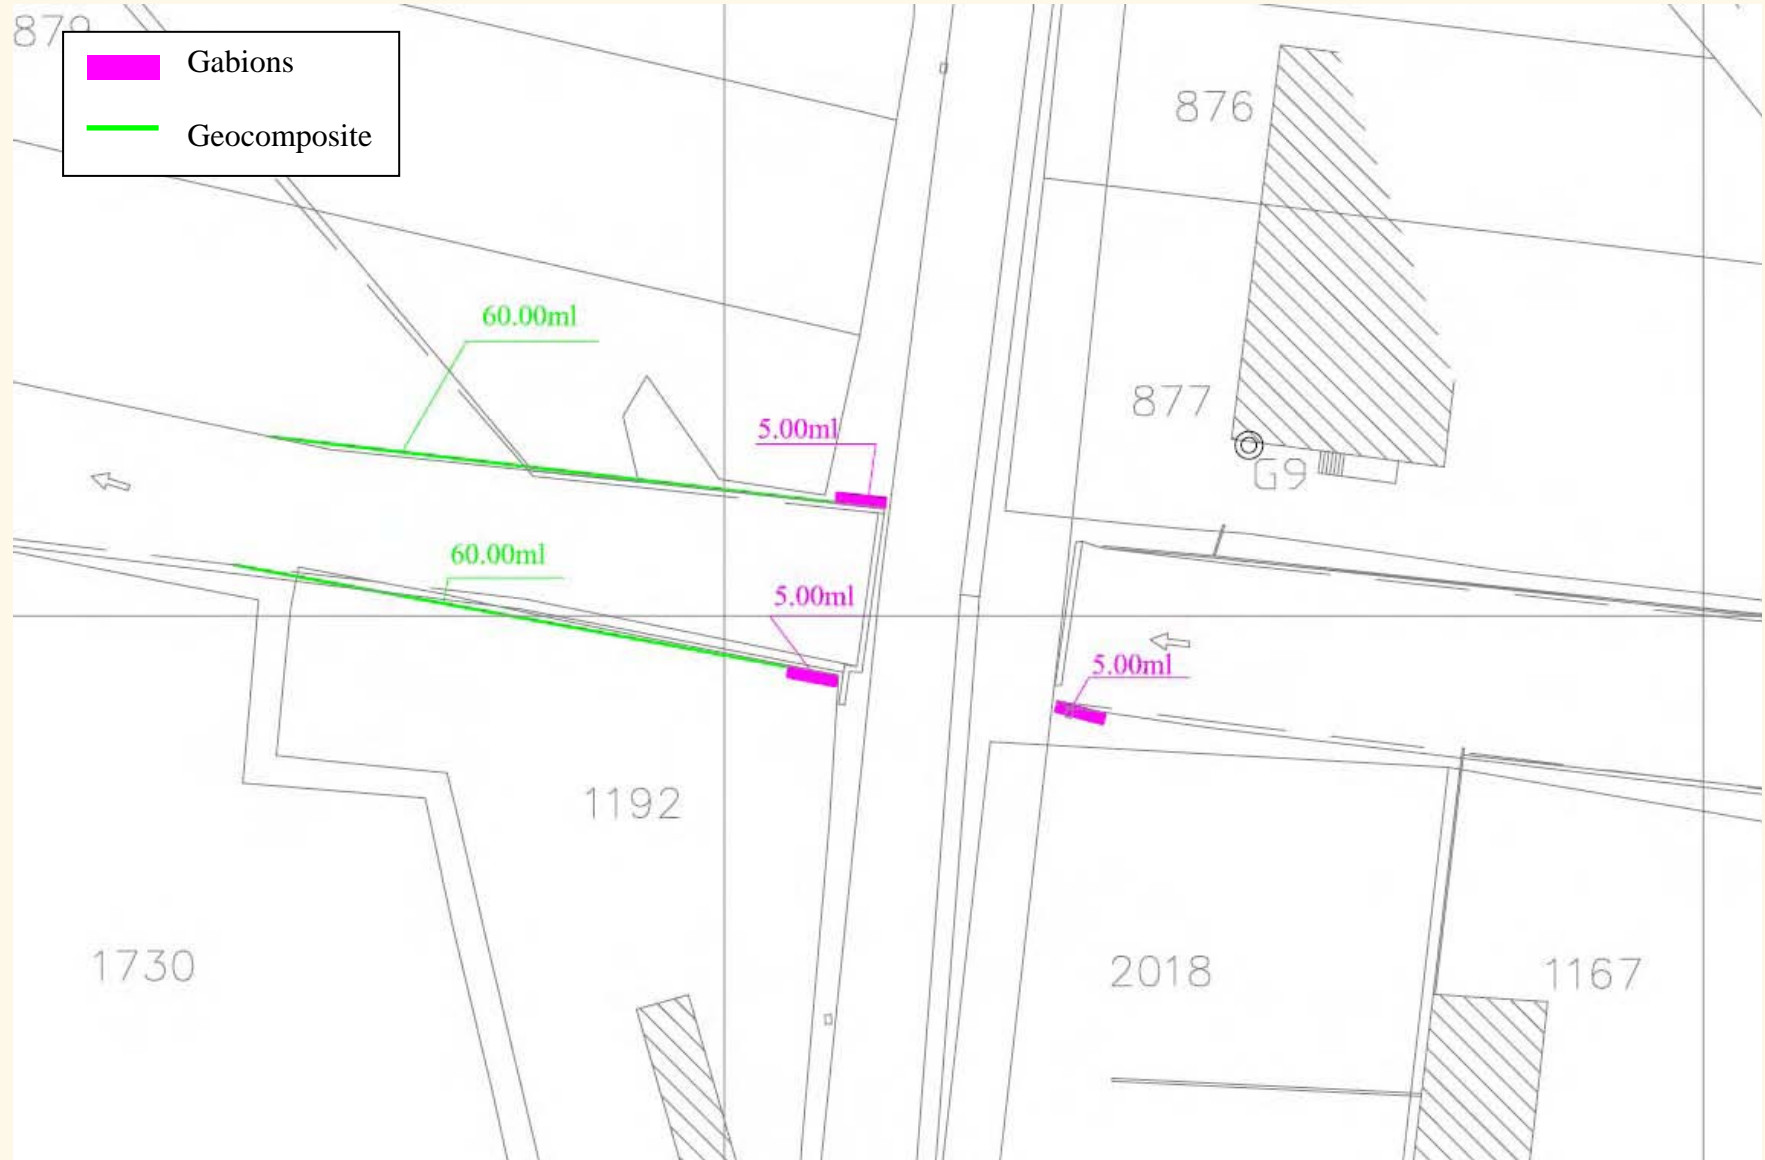
PROJECT PLAN

Reference Data: Ghzaiyel River, Damascus Road, G1 POINT

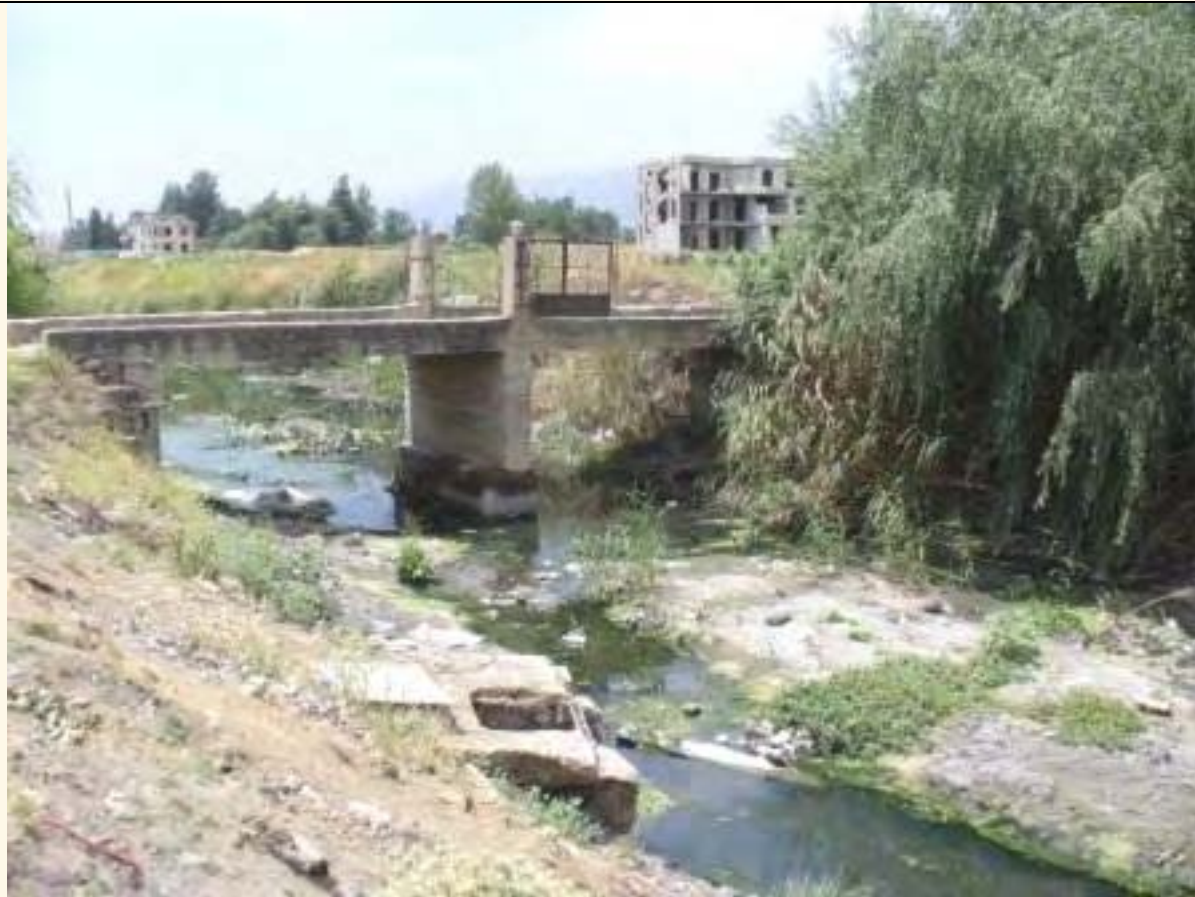
The situations of the Gzayel River before the jobs were characterized by river banks without protection and with signs of erosion. The bed of the river in proximity of the bridge was tall due to the solid deposition. This limits the flow that could pass through the bridge. The width of the section was variable and locally was too much low to permit the regular flow of the water in case of peak flows. This situation causes several cases of flooding with bad conditions for the agriculture and the houses situated in proximity of the river.

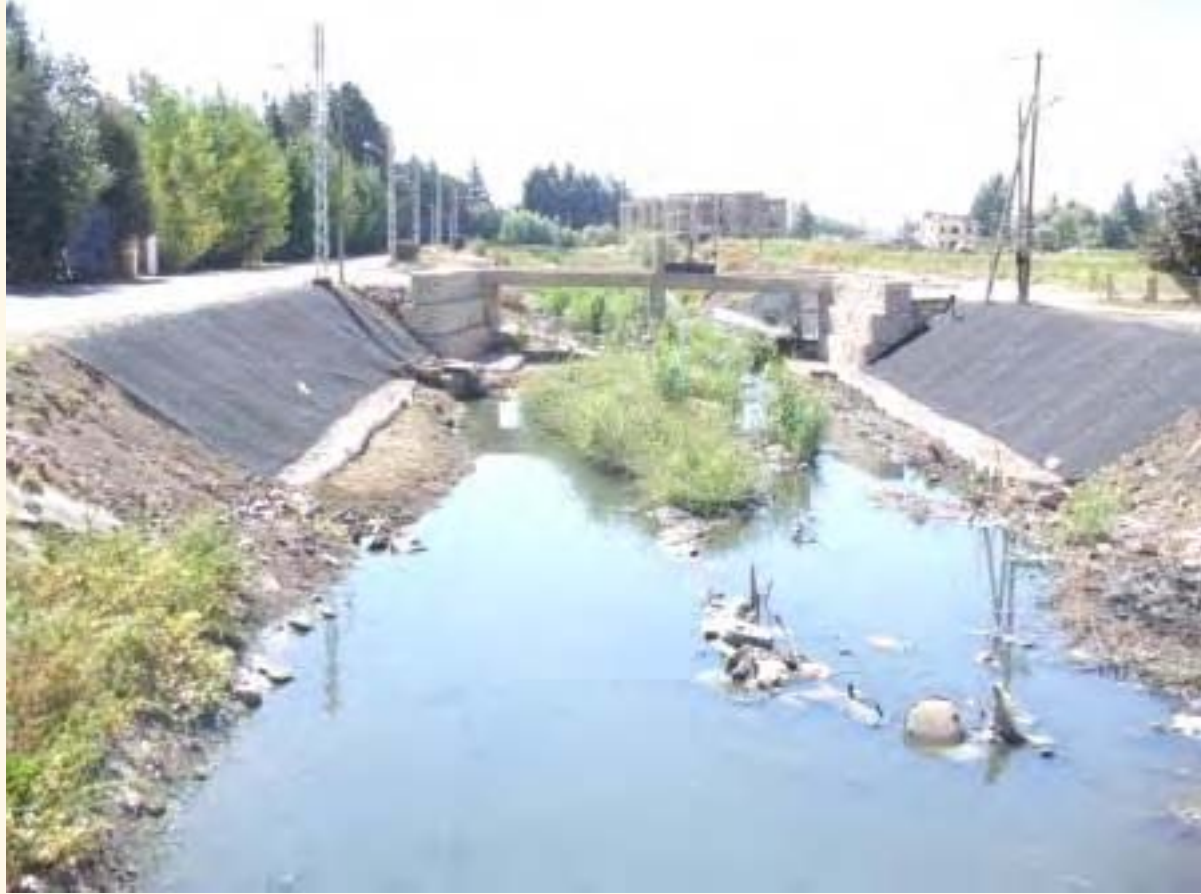
The works has been completed according to the project previsions and the hydraulic evaluation carried out with the support of the Litani River Authority. We had reached better conditions for the river flows. The recalibration of the river bed and banks have granted safer condition for the bridge.
