Improvement of Irrigation Water Management in Lebanon & Jordan

FINAL REPORT

Rehabilitation of the River Litani and the affluents

Bekaa Valley

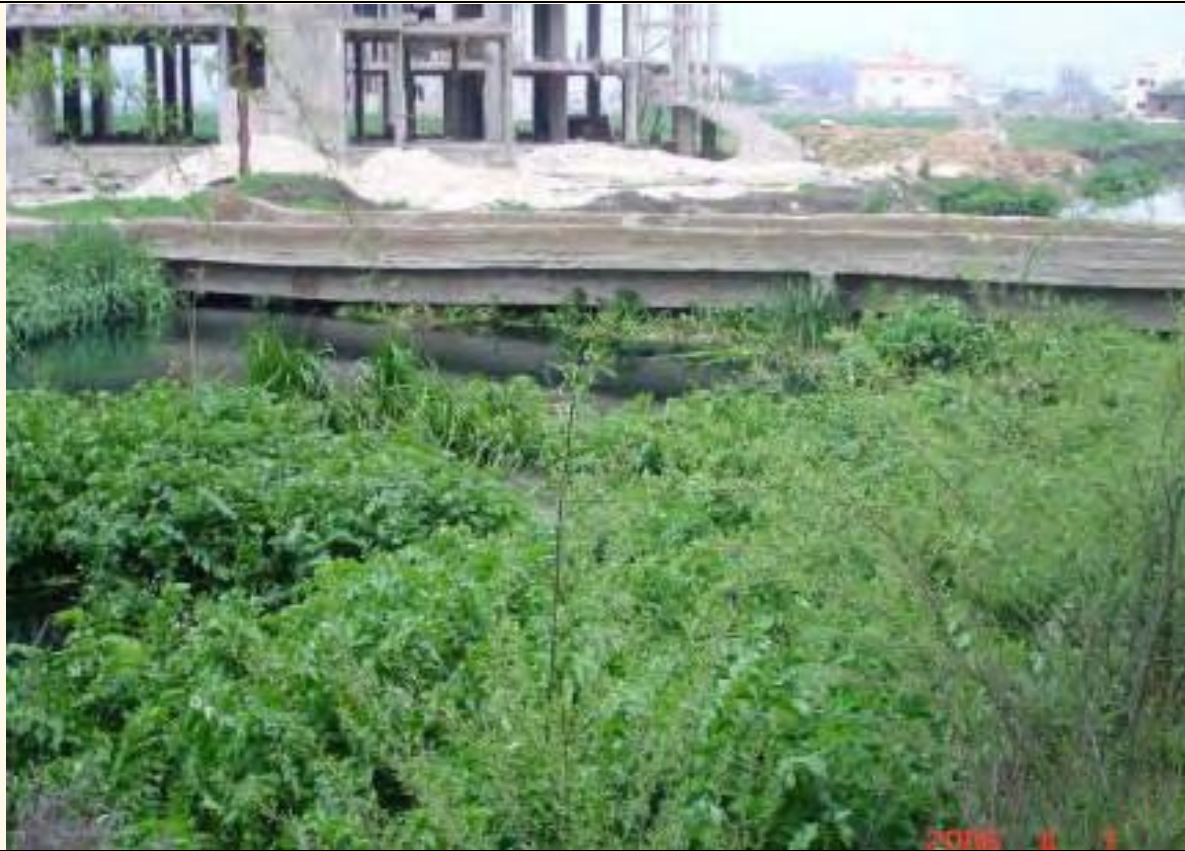
The situations of the Gzayel River before the jobs were characterized by river banks without protection and with signs of erosion. The bed of the river in proximity of the bridge was tall due to the solid deposition and vegetation. This limits the flow that could pass through the bridge. The width of the section was variable and locally was too much low to permit the regular flow of the water in case of peak flows. This situation causes several cases of flooding with bad conditions for the agriculture and the houses situated in proximity of the river.

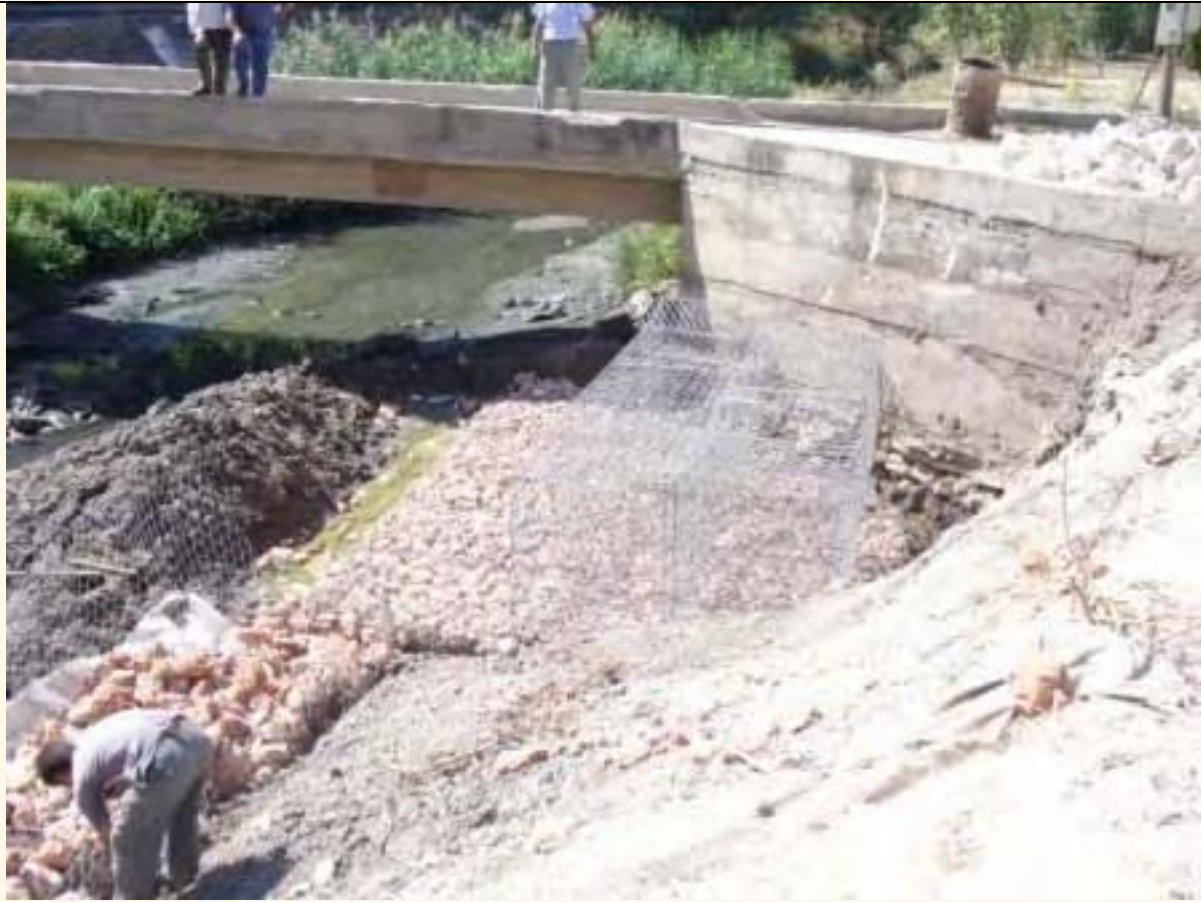
The works has been completed according to the project previsions and the hydraulic evaluation carried out with the support of the Litani River Authority. We had reached better conditions for the river flows. The recalibration of the river bed and banks have granted safer condition for the bridge. The new protections (gabions and mattresses)of the river banks are more sustainable and permit a simple maintenance. Cultivated lands and houses are more safer from the flooding

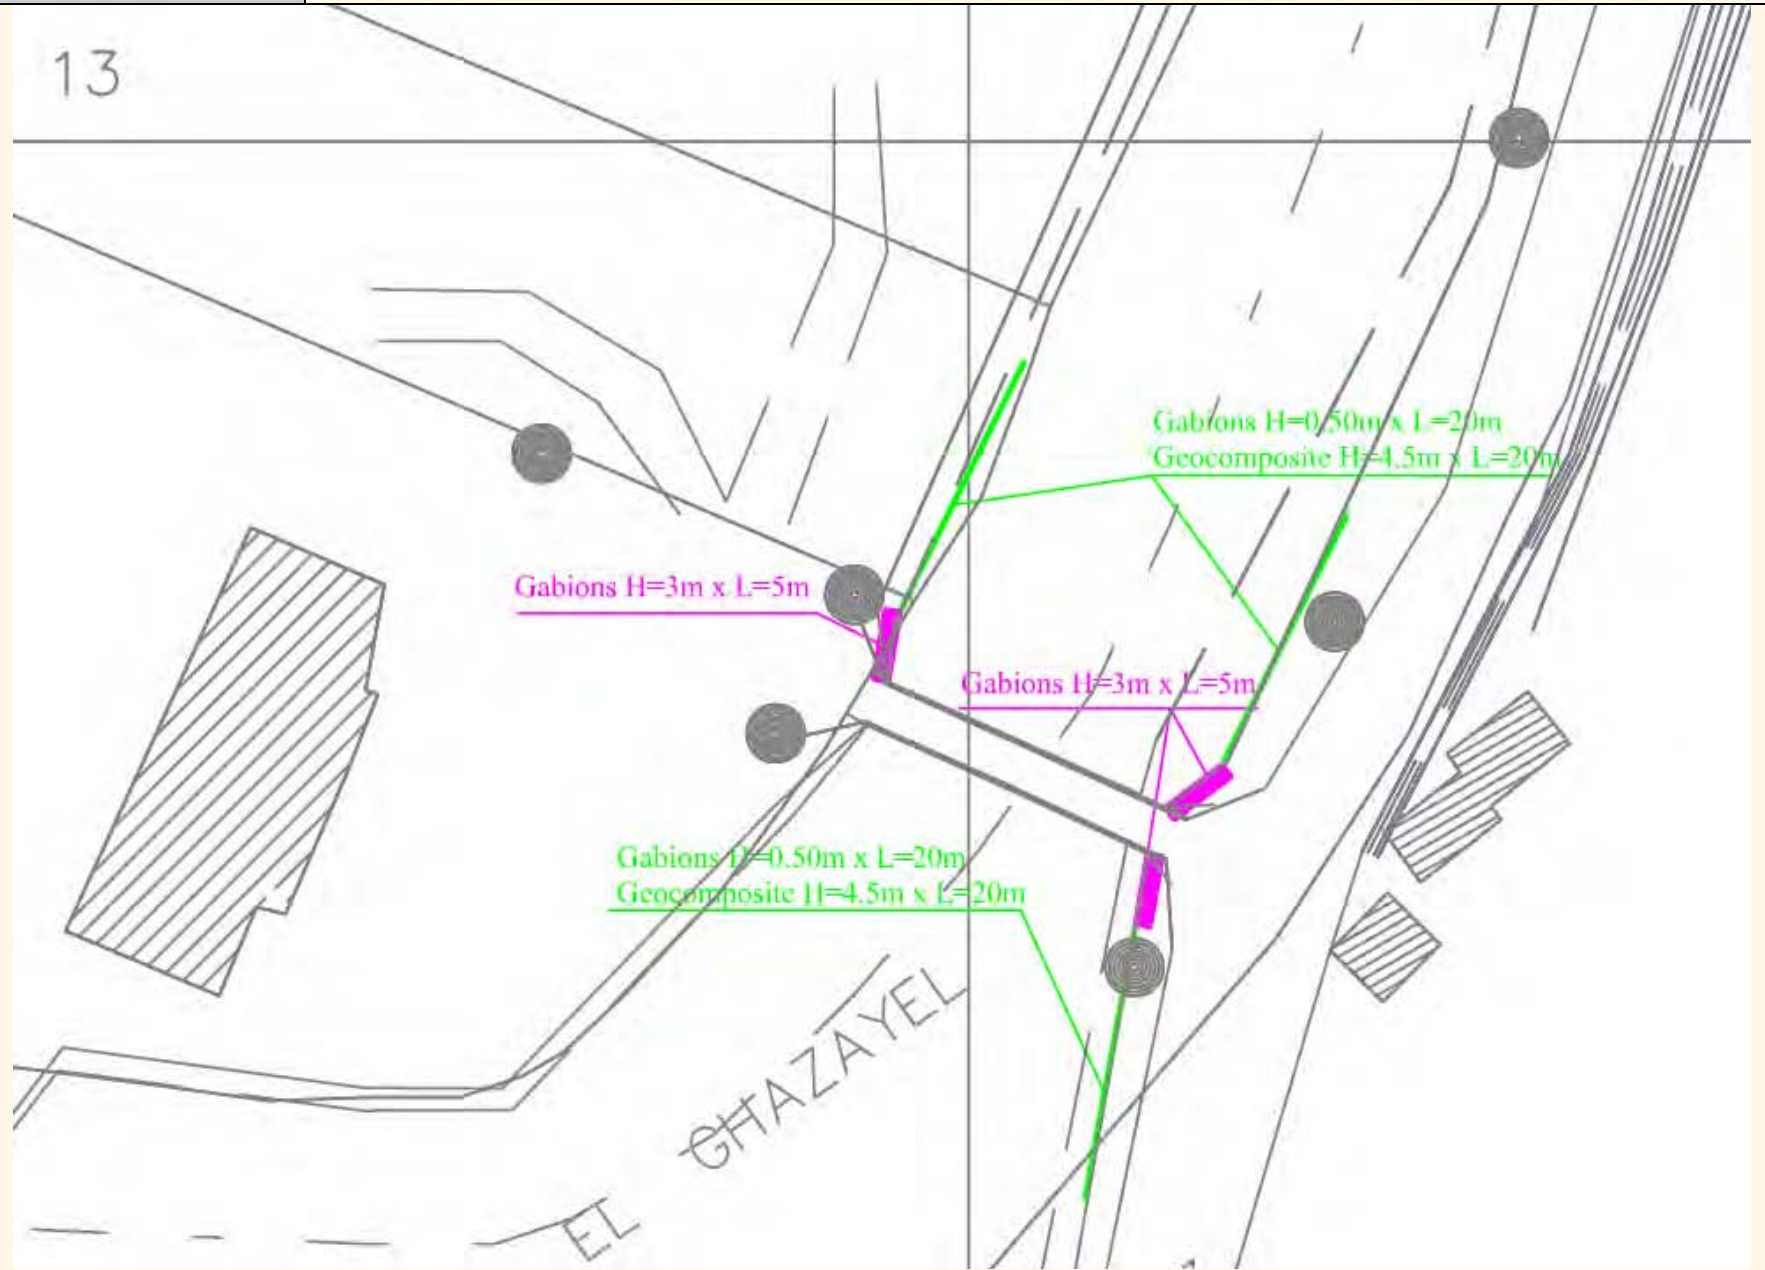
AS - BUILT CONDITIONS

Reference Data: Ghzaiyel River, G7 POINT

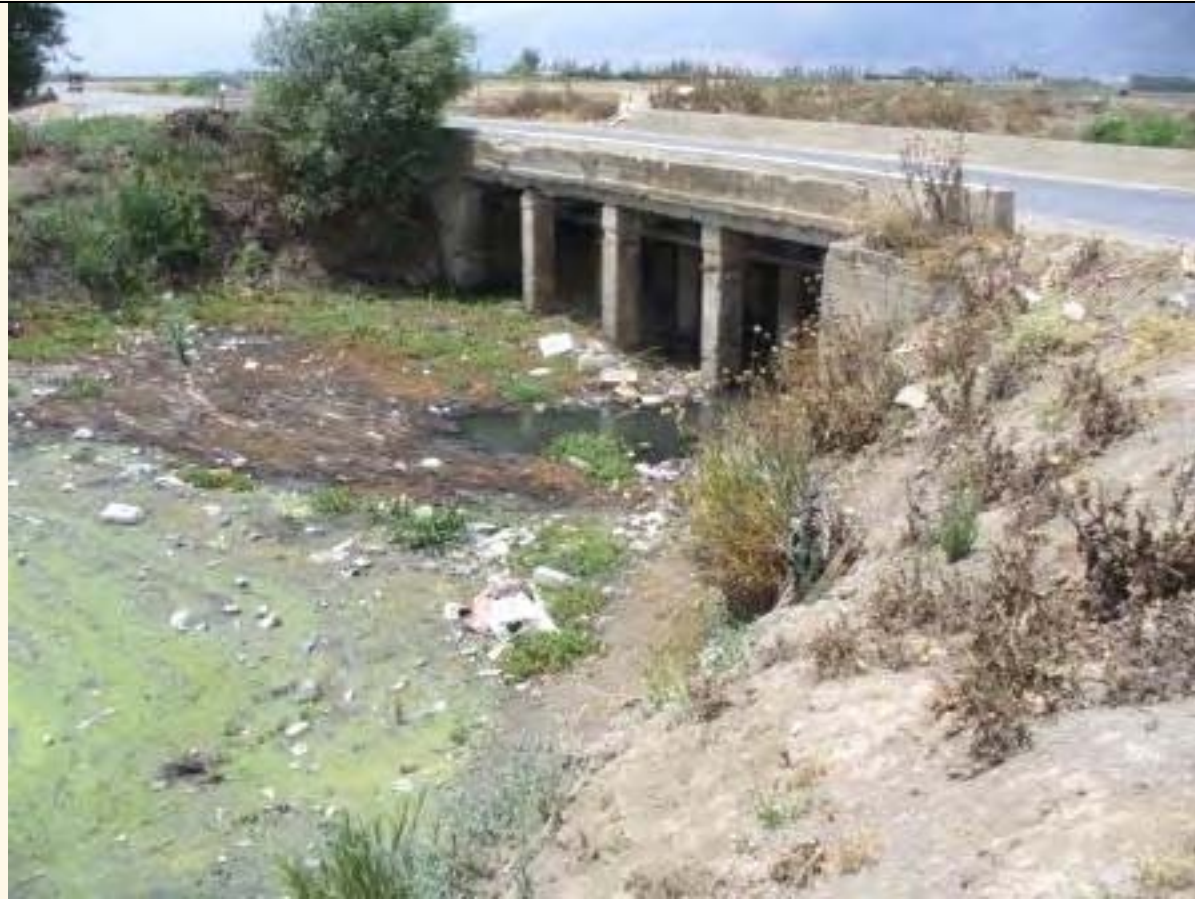
The situations of the Gzayel River before the jobs were characterized by river banks without protection and with erosion. The bed of the river in proximity of the bridge was tall due to the solid deposition. This limits the flow that could pass through the bridge. The width of the section was variable and locally was too much low to permit the regular flow of the water in case of peak flows. This situation causes several cases of flooding with bad conditions for the agriculture and the houses situated in proximity of the river.

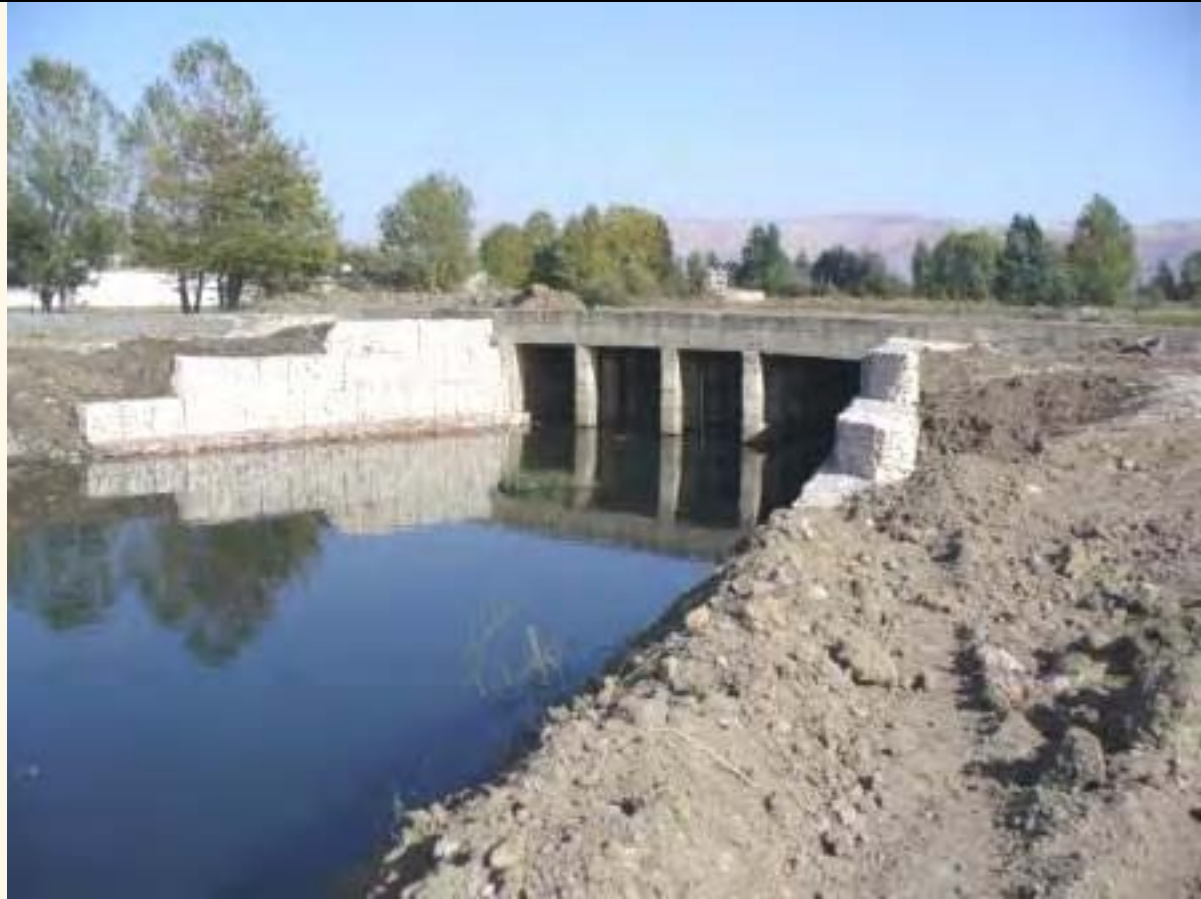
The works has been completed according to the project previsions and the hydraulic evaluation carried out with the support of the Litani River Authority. We had reached better conditions for the river flows. The recalibration of the river bed and banks have granted safer condition for the bridge. The new protections (gabions and mattresses)of the river banks are more sustainable and permit a simple maintenance. Cultivated lands and houses are more safer from the flooding

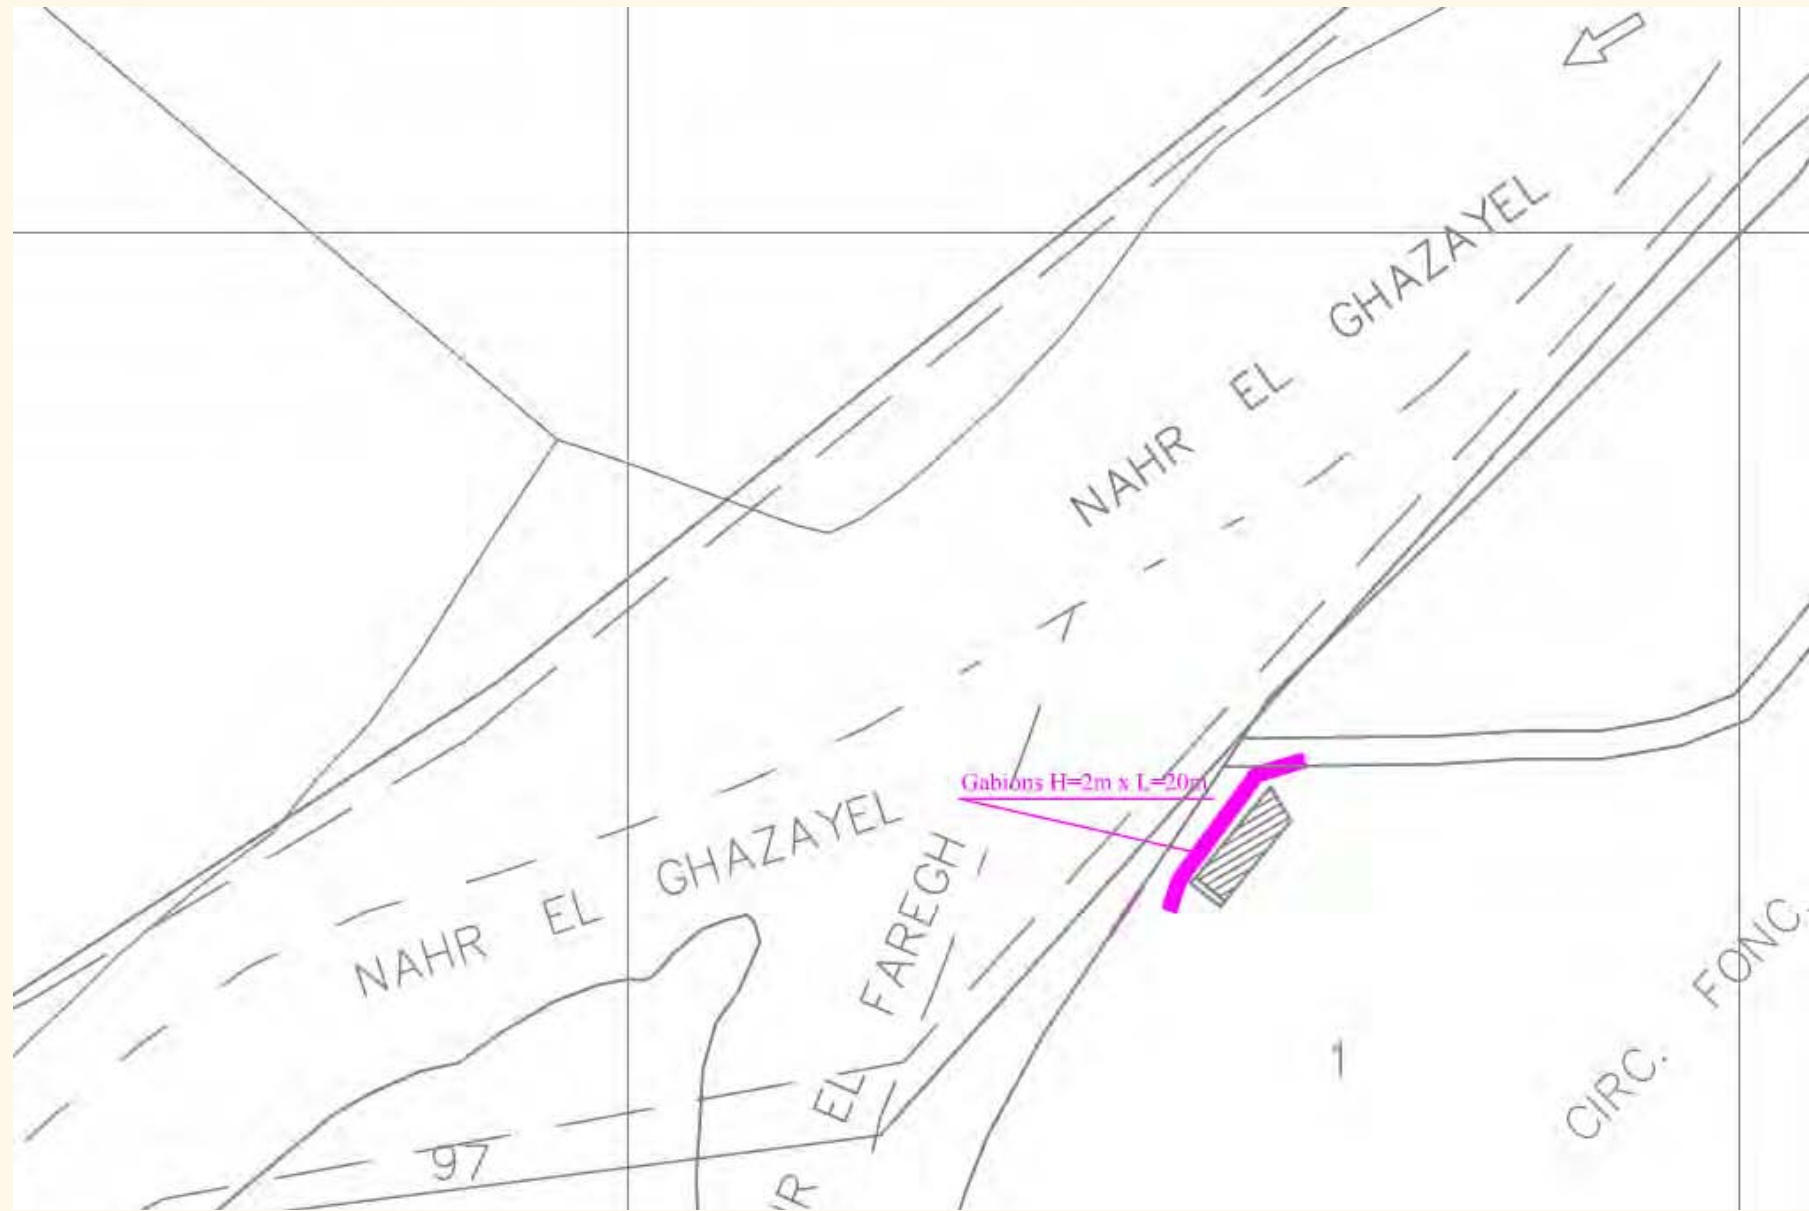
AS - BUILT CONDITIONS

Ghzaiyel River, Faregh River, GF10 POINT

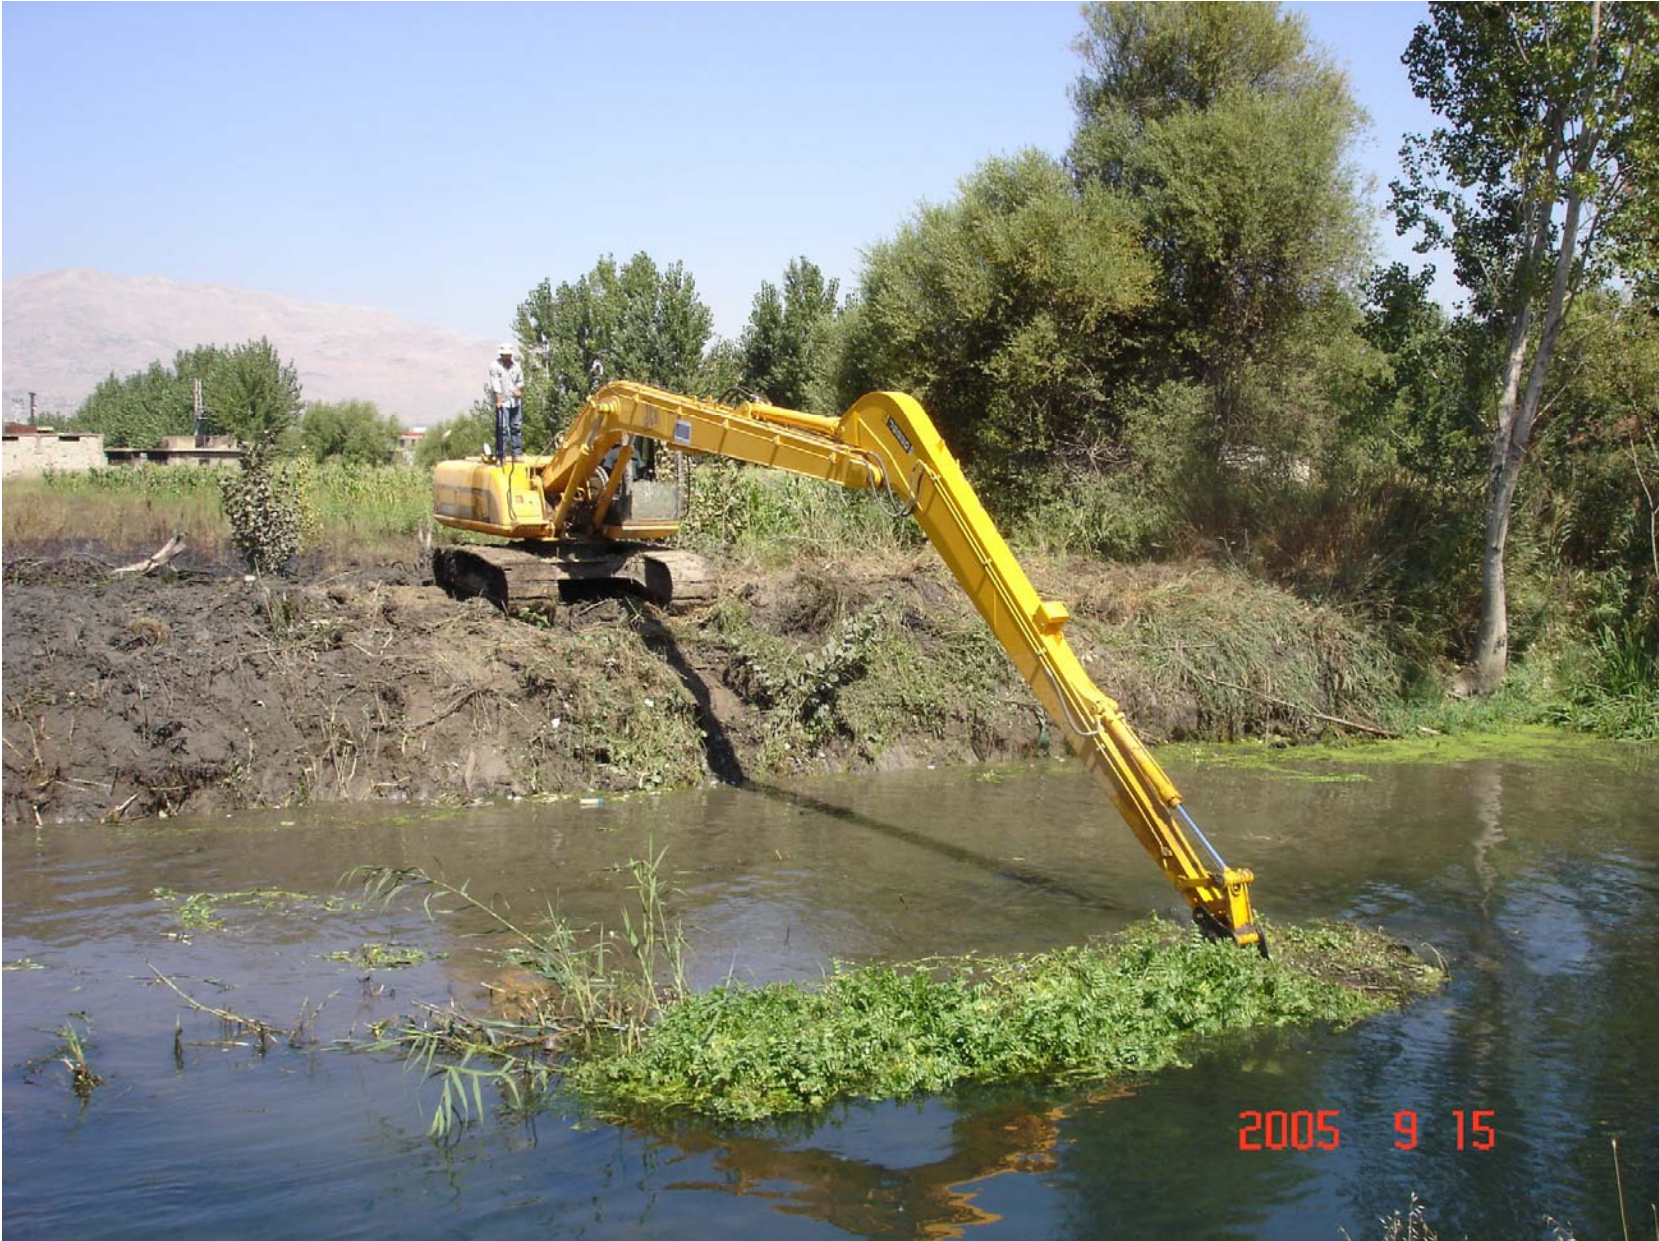
River cleaning using the machines provided by IrWa
